Beachie Creek Fire

Erosion Threat Assessment/Reduction Team (ETART)
Extended Report

December 2020

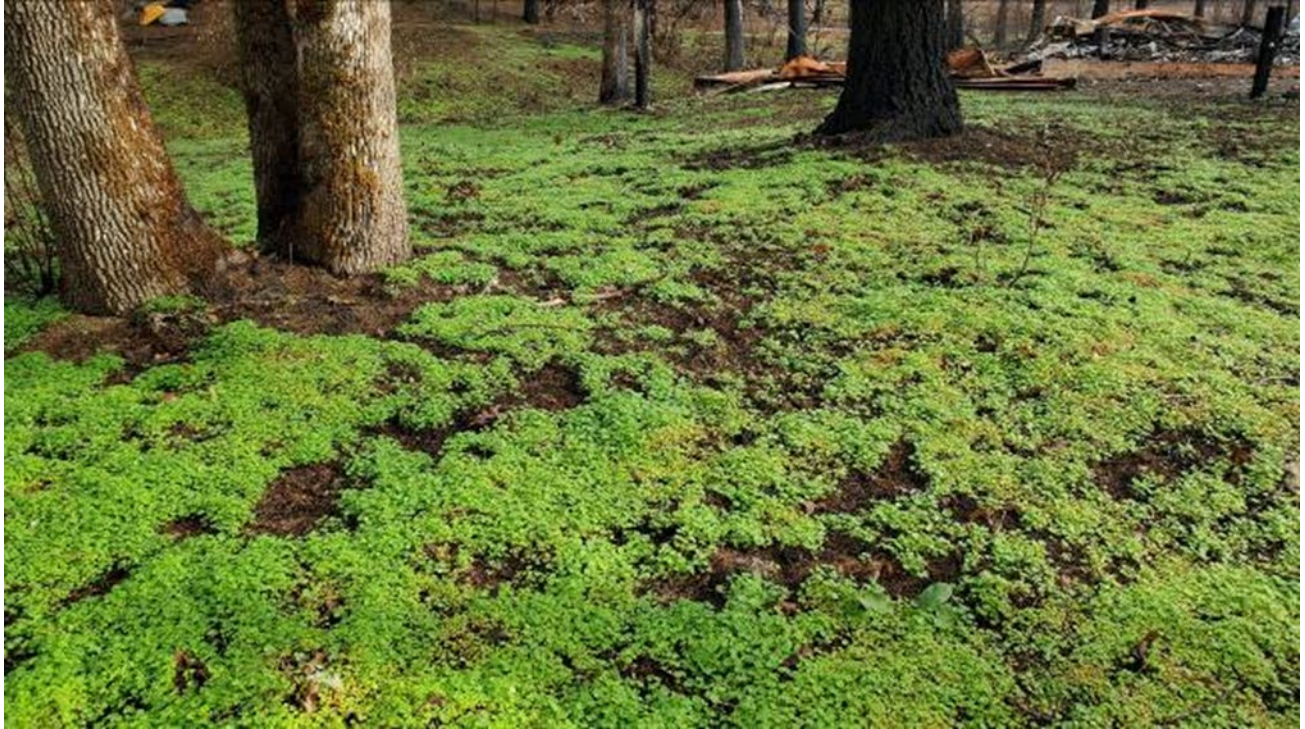
Photo 1. Shiny Geranium sprouting extensively after fire

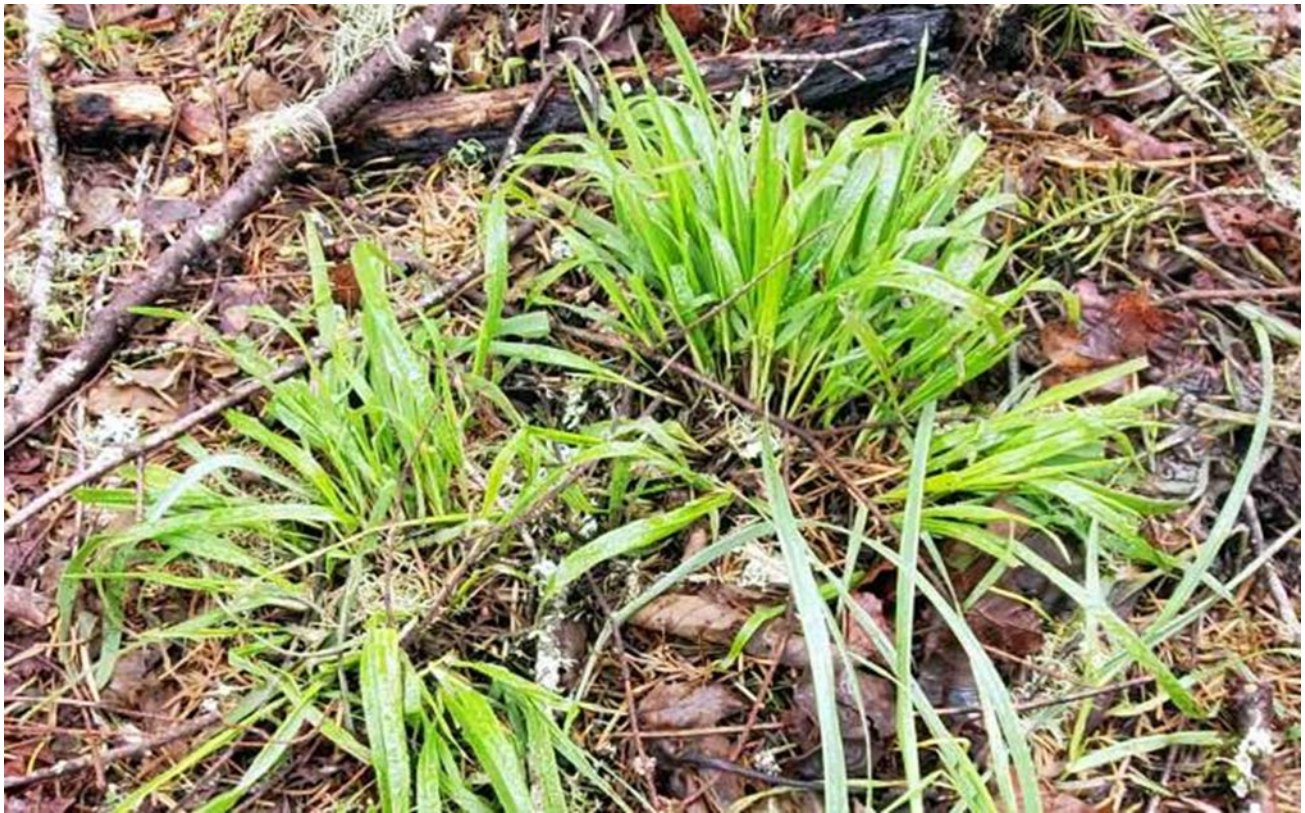
Photo 2. False Brome re-sprouting after fire

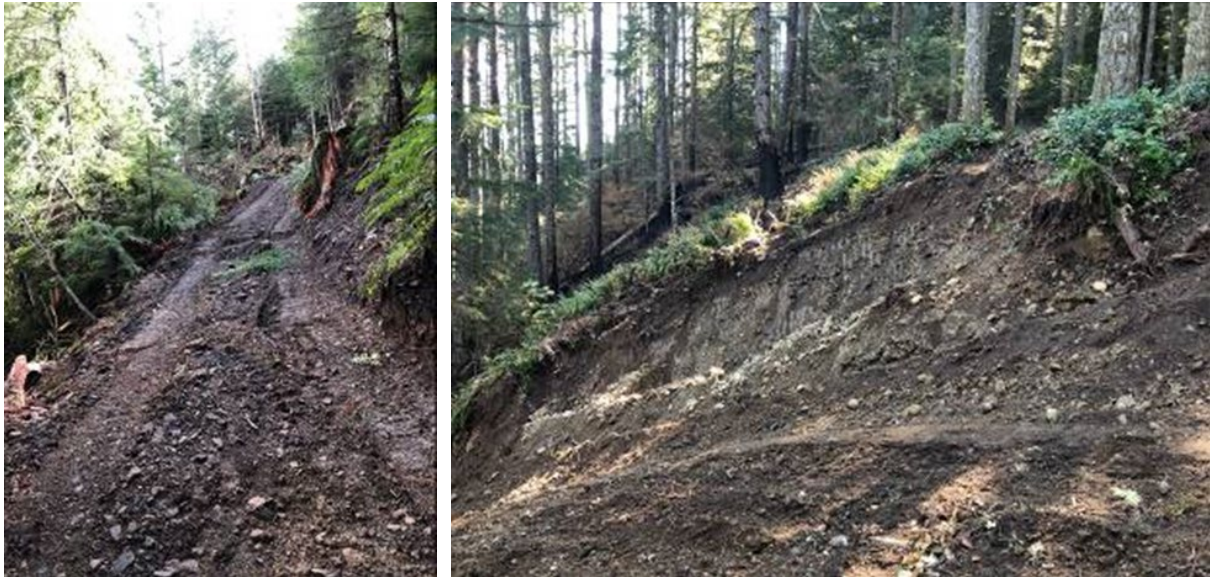
Photo 3. & 4. Dozer lines in Silver Falls State Park

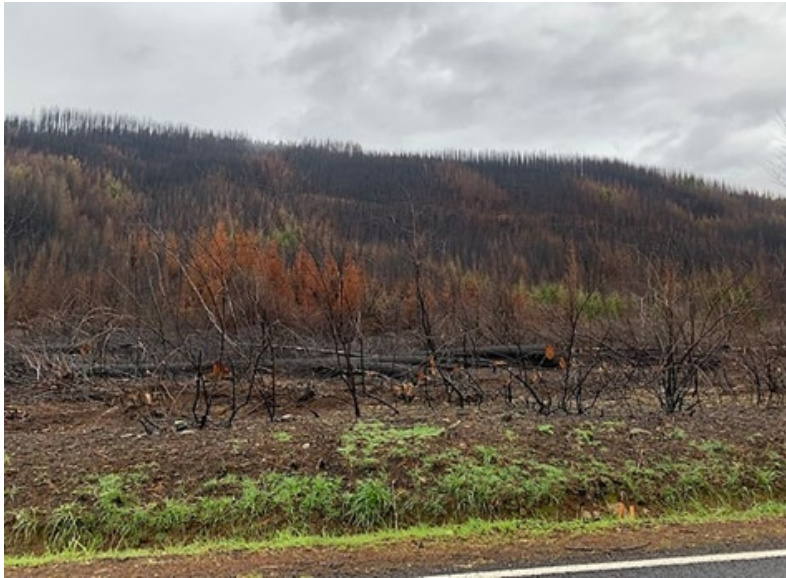
Photo 5. Salvaged timber is vulnerable to new weed infestations. Location: Near Little North Fork Rd.

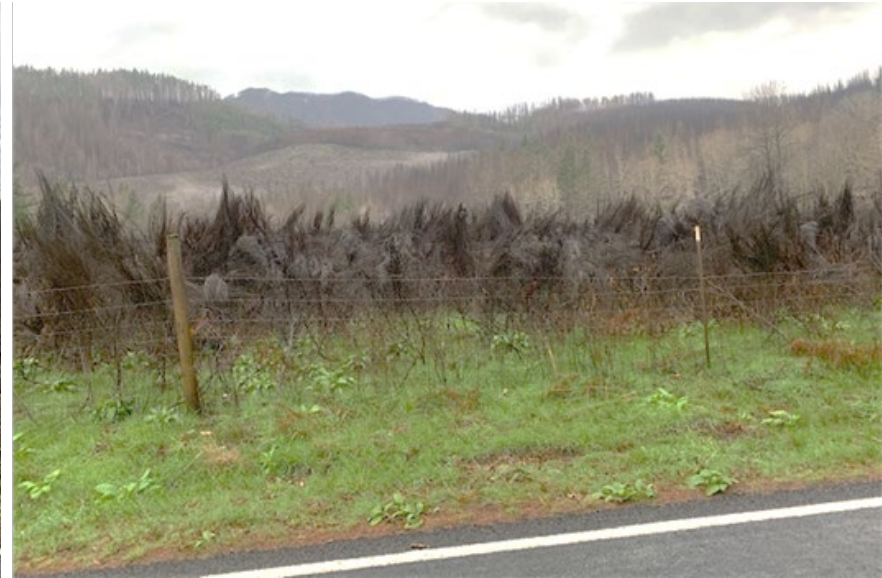
**Photo 6. Burned field of Scotch Broom
Existing seed source along Little North Fork Rd. near MP 13**

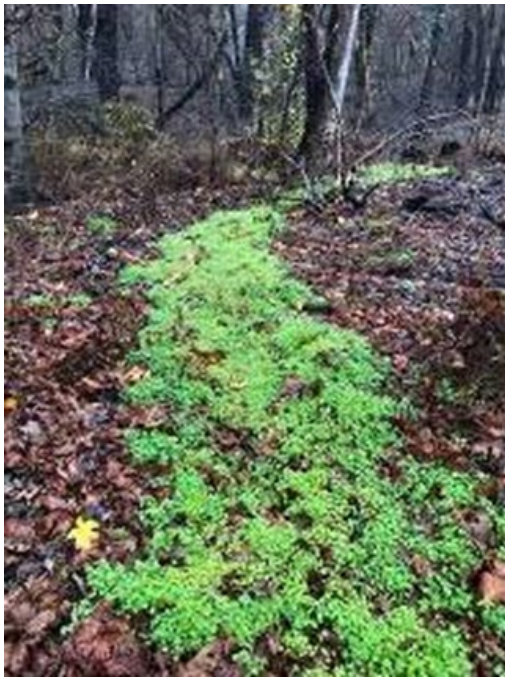
Photo 7. Shiny Geranium growing along a recreation trail

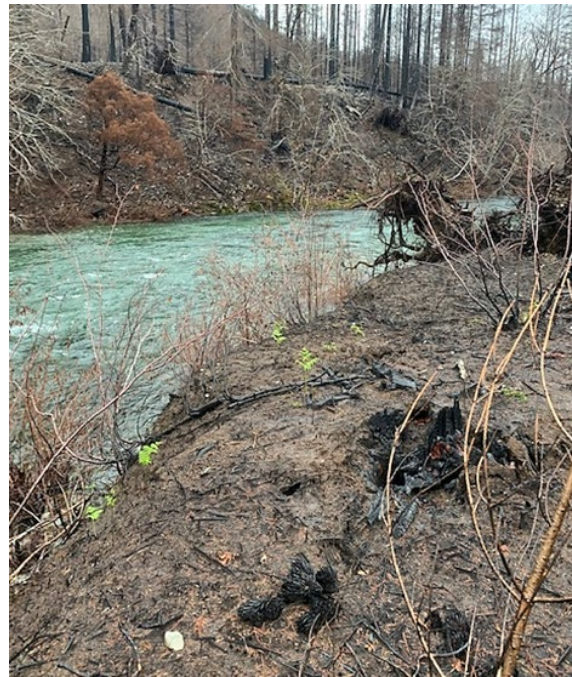
Location: Little North Fork Santiam at Elk Horn

Photo 8. Burned riparian area vulnerable to weed infestations

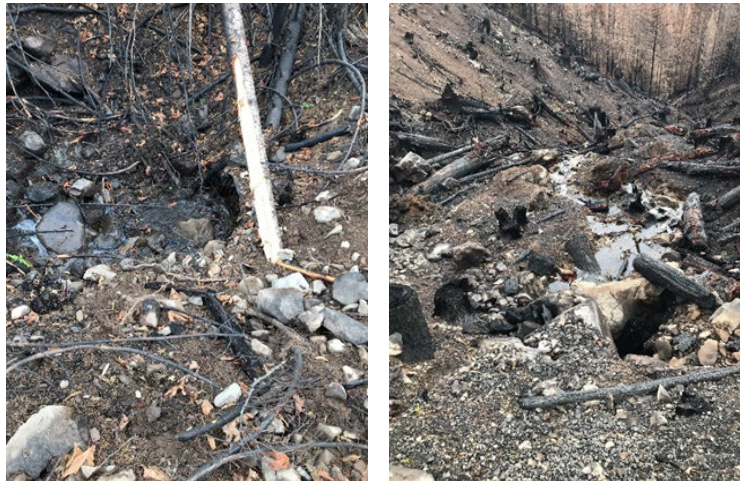
Photos 1 and 2: Culverts along Copper Creek mainline

The Copper Creek ML has multiple culverts that are at risk of damage from erosion due to plugging/blocking. This often occurs when ash and sediment loads are deposited into roadside ditches. When a storm event occurs the ash and sediment collect at the inlet of a culvert so that it has the potential to become plugged. The culverts are also not designed for increased flows and have a high potential for overtopping/failure. There are multiple ditch relief culverts along the 3.19 miles of Copper Creek ML within burned area. These sections are at risk of plugging/failing, resulting in property loss and natural resource damage from increased sedimentation to the watersheds.

Recommendation (all): Clean culverts, run out ditches, and catchment basins of sediment, debris and rock. Replace or repair damaged culverts pending the need of primary maintainers. Slotted riser pipes or culvert end sections could be installed where feasible and appropriate to reduce the possibility of sediment and debris plugging of existing culverts.

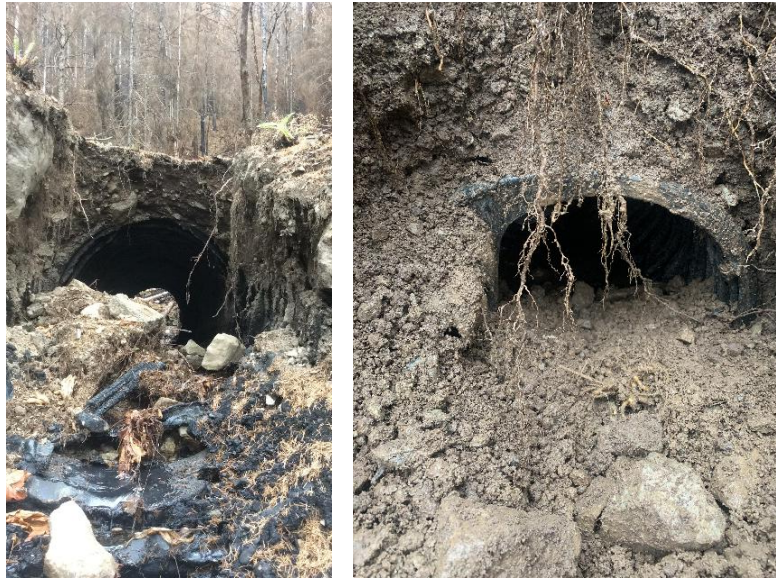
Photos 3 and 4: Culverts along Copper Creek mainline

Santiam State Forest roads primarily lie within areas that were moderate to high intensity that resulting in damage and immediate risks to further damage due from erosion to plugging. Post fire assessments have noted numerous drainage structures that are not functioning due physical damage (burned) which have decreased the capacity to convey water. The increase in sediment load is also decreasing water capacity as rain events are increasing in frequency. The loss of the herbaceous and small brush component within the ditches and slopes is resulting in drainage structures to fill with fine sediment. To ensure proper function continues through rain and storm events, there will be a need to storm proof and monitor the roads until the threat has been reduced or repairs have occurred.

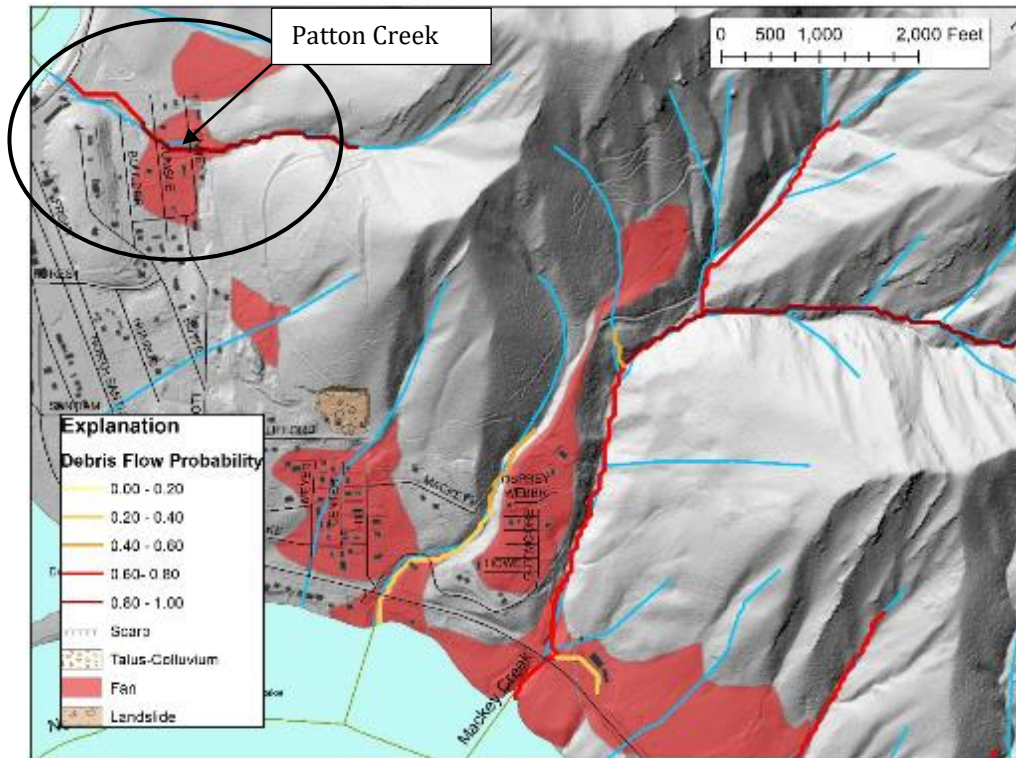
Figure 2: Town of Detroit buildings and infrastructure at potential landslide risk. Map includes USGS debris flow hazard channels and DOGAMI SLIDO debris flow fans (deposit) and landslide areas. Potentially high hazard emanating from Patton Creek drainage area into neighborhood built on fan deposits.

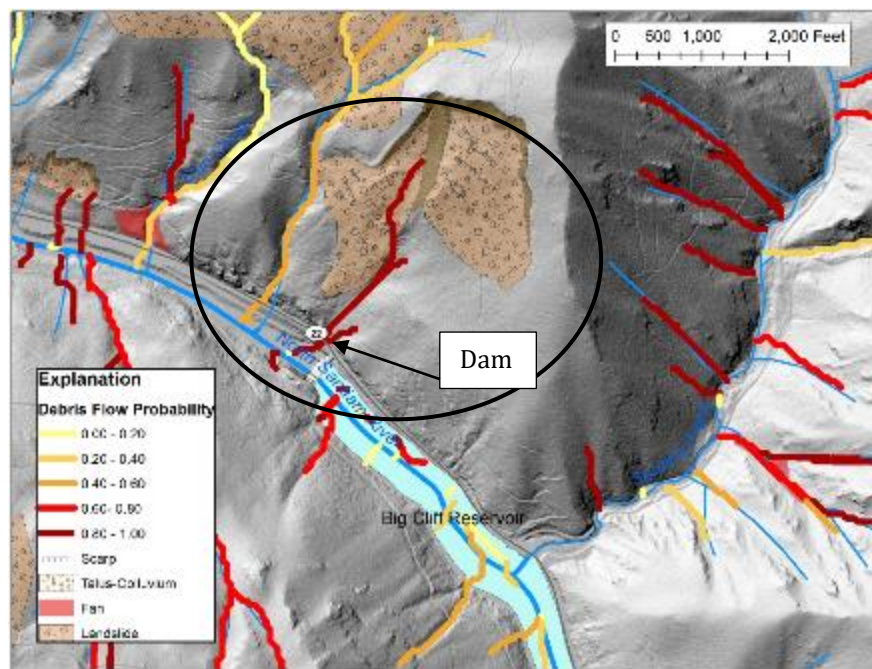
Figure 3: Big Cliff Dam facility and OR22 highway at risk. Includes USGS debris flow hazard channels and DOGAMI SLIDO debris flow fans (deposit) and landslide areas. Potentially high hazard emanating from unnamed drainage above dam facility and highway.

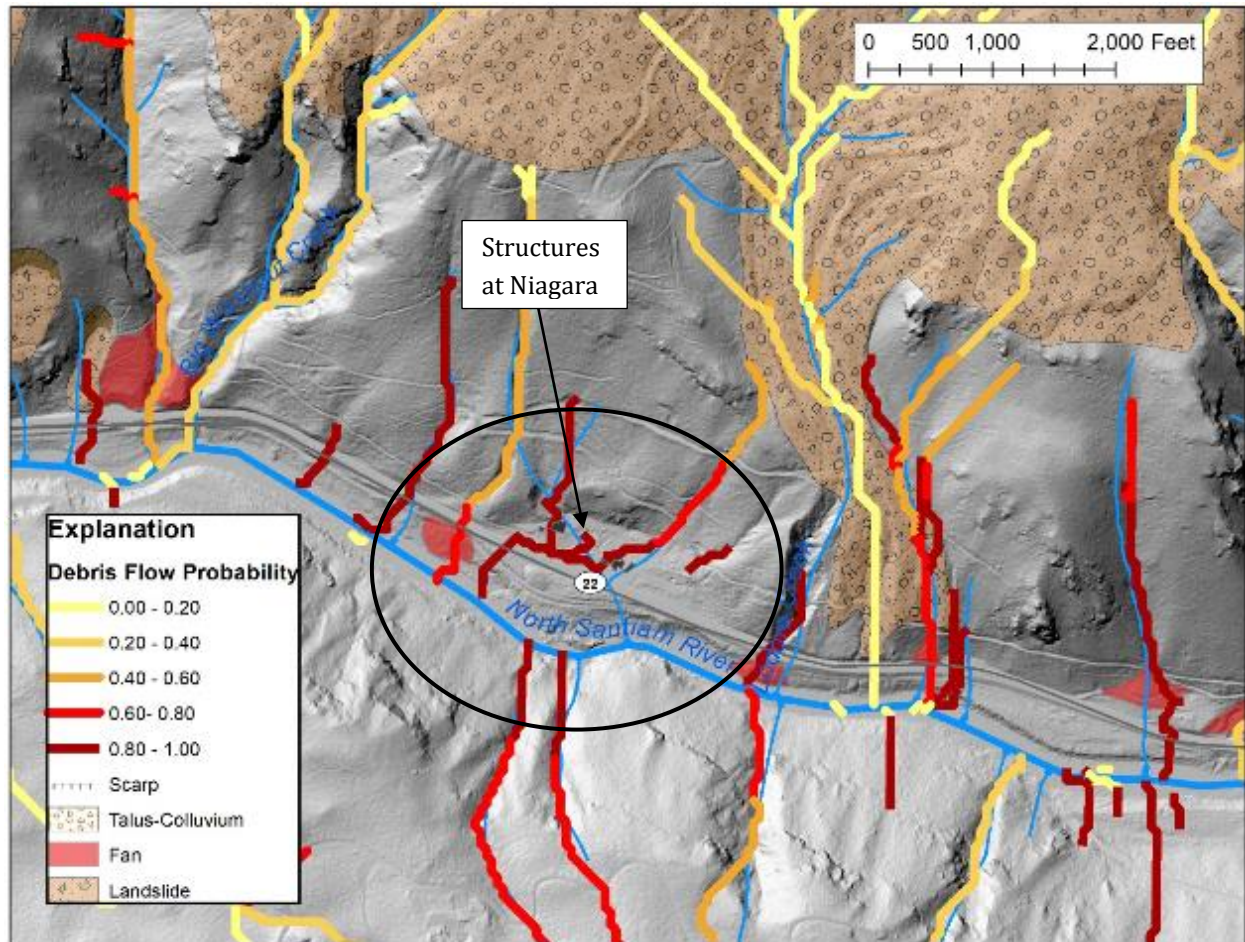
Figure 4: Map of the buildings and infrastructure at risk in the area of Niagara. Includes USGS debris flow hazard channels and DOGAMI SLIDO debris flow fans (deposit) and landslide areas. Potentially high to very high hazard emanating from creek drainage area into neighborhood built below steep channels.

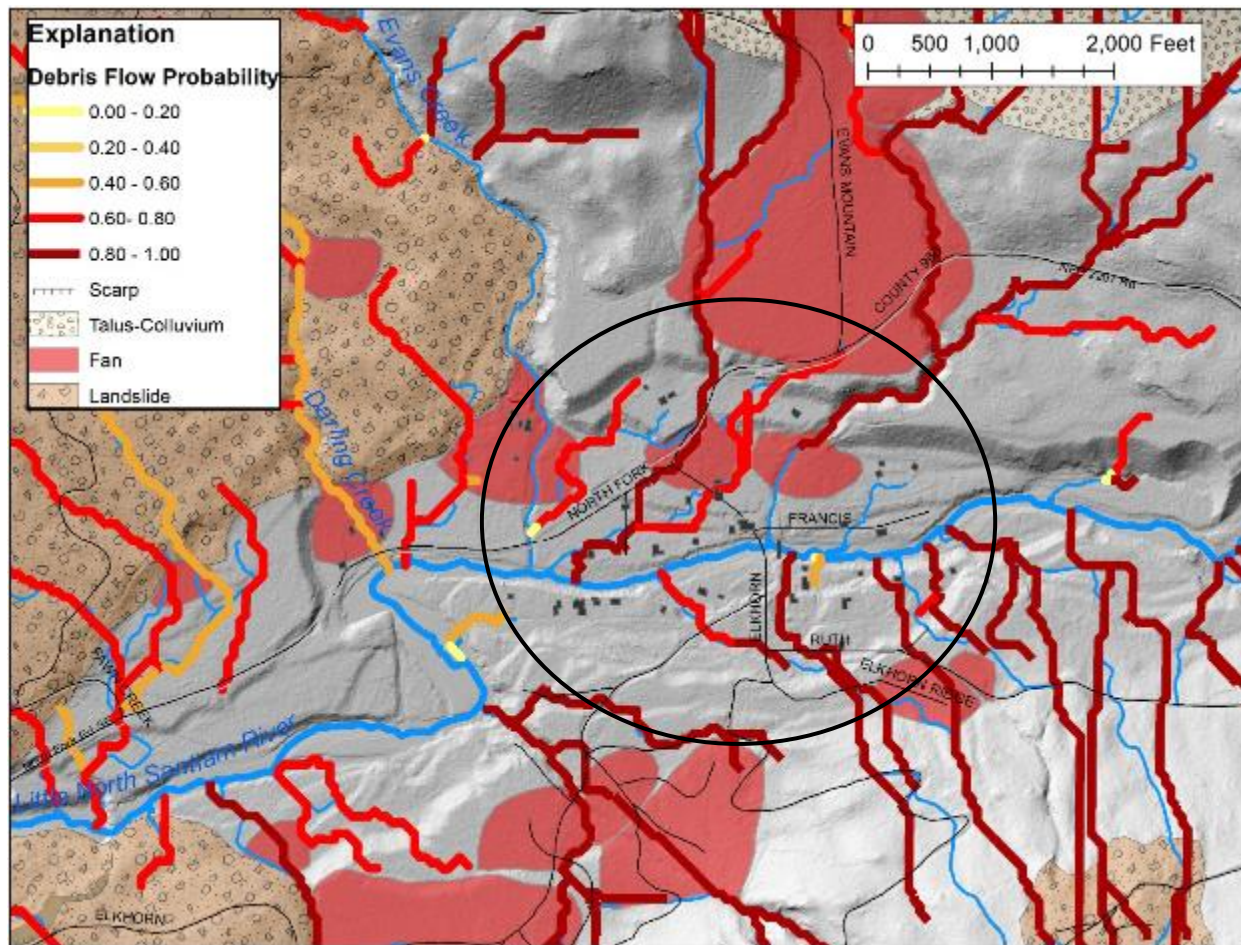
Figure 5: Map of community of Elkhorn along the Little North Santiam River. Buildings and infrastructure at moderate to high risk from debris flows and landslides. Includes USGS debris flow hazard channels and DOGAMI SLIDO debris flow fans (deposit) and landslide areas. Potentially high to very high hazard emanating from creek drainage area into neighborhood built below steep channels.

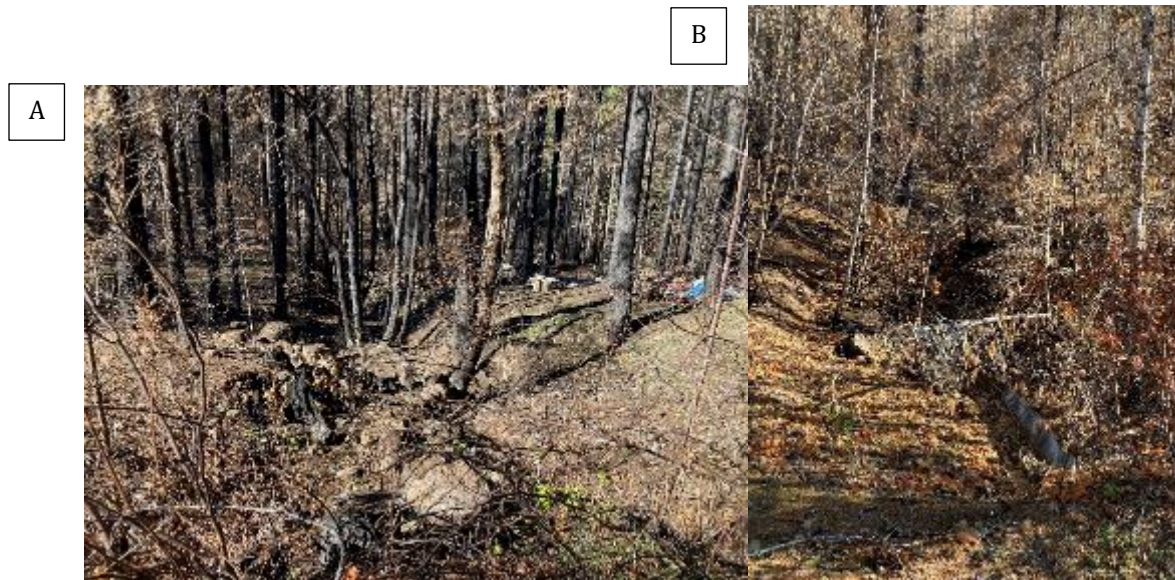
Photo 1: (A) Patton Creek at Kinney Ave. in Detroit looking downstream. (B) Patton Creek looking upstream. Refer to Figure 2 above for location. Patton Creek flows diagonally across Detroit neighborhood and has potentially a high hazard emanating from the burned drainage above the neighborhood.

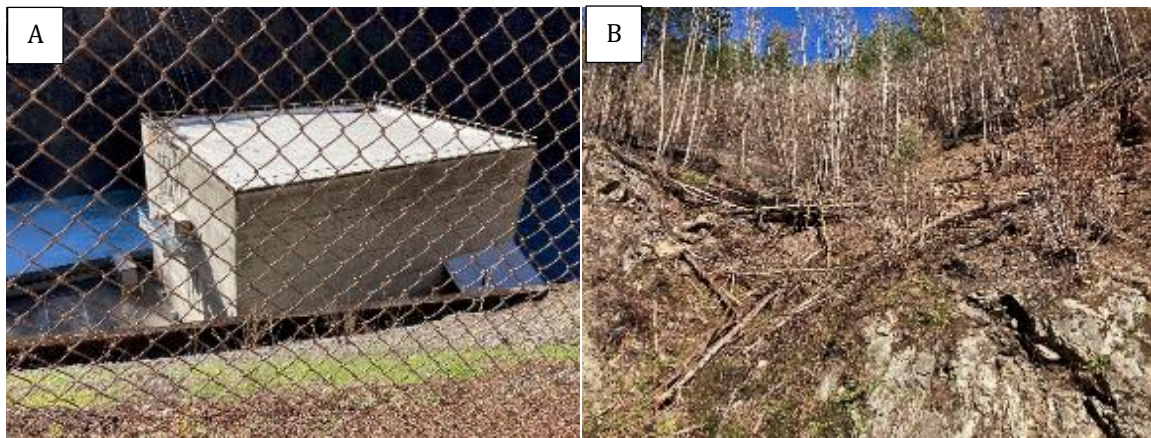
Photo 2: (A) Big Cliff Dam facility and Steep channel above facility and OR22 with loose bedload material and wood debris. Refer to Figure 3 above. Potentially high hazard emanating from unnamed drainage above dam facility and highway.

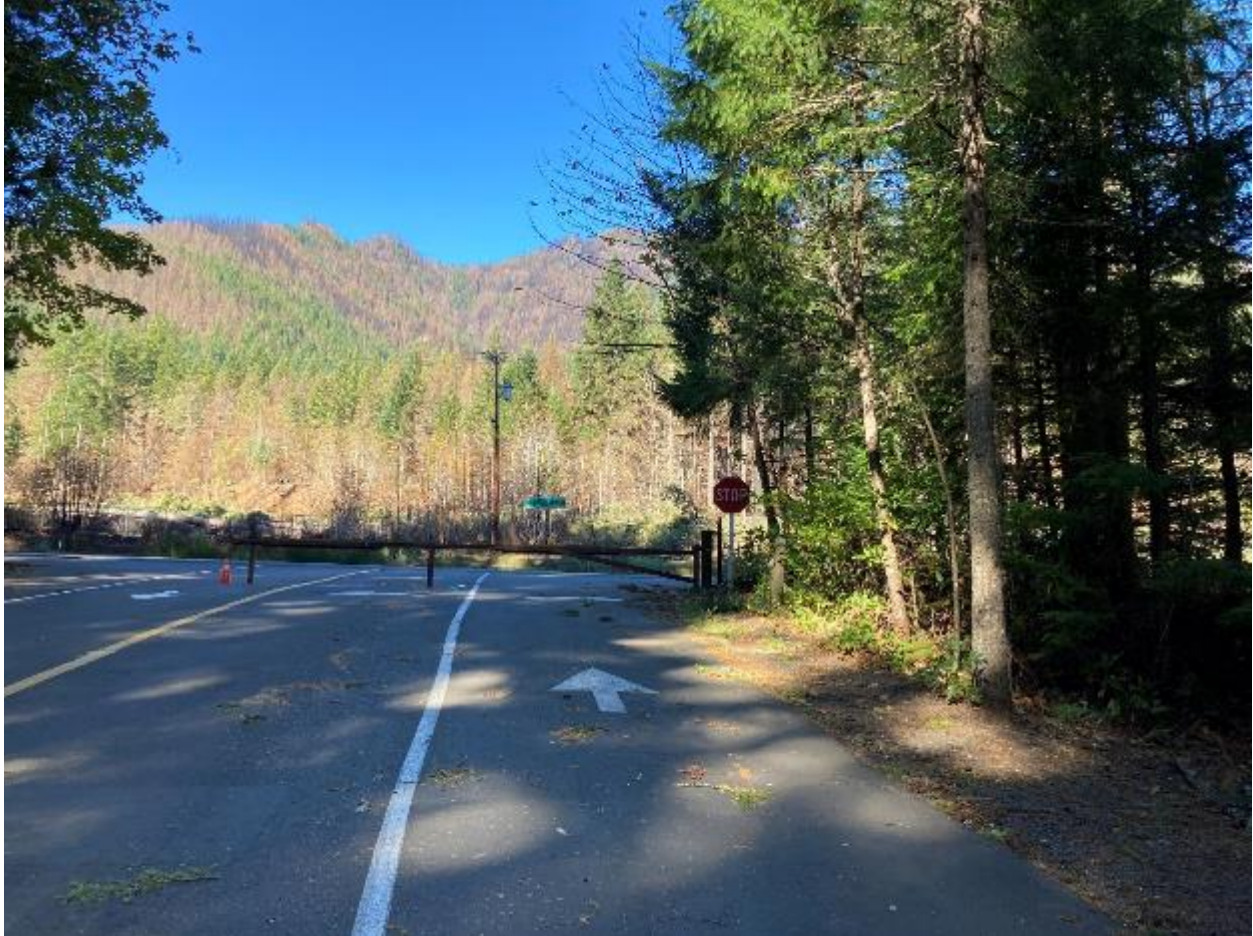
Photo 3: Detroit Lake State Park entrance off OR22. In the watershed in the background was burned by the fire. Just off the right side is one of the channels emanating from this watershed which is unburned. Debris flows form in the burned upper watershed and can rapidly travel downstream through channels that are not burned. This channel runs very close to the campground host sites and the visitor center. The state park is located on an alluvial fan deposits which was formed by many debris flow over time.

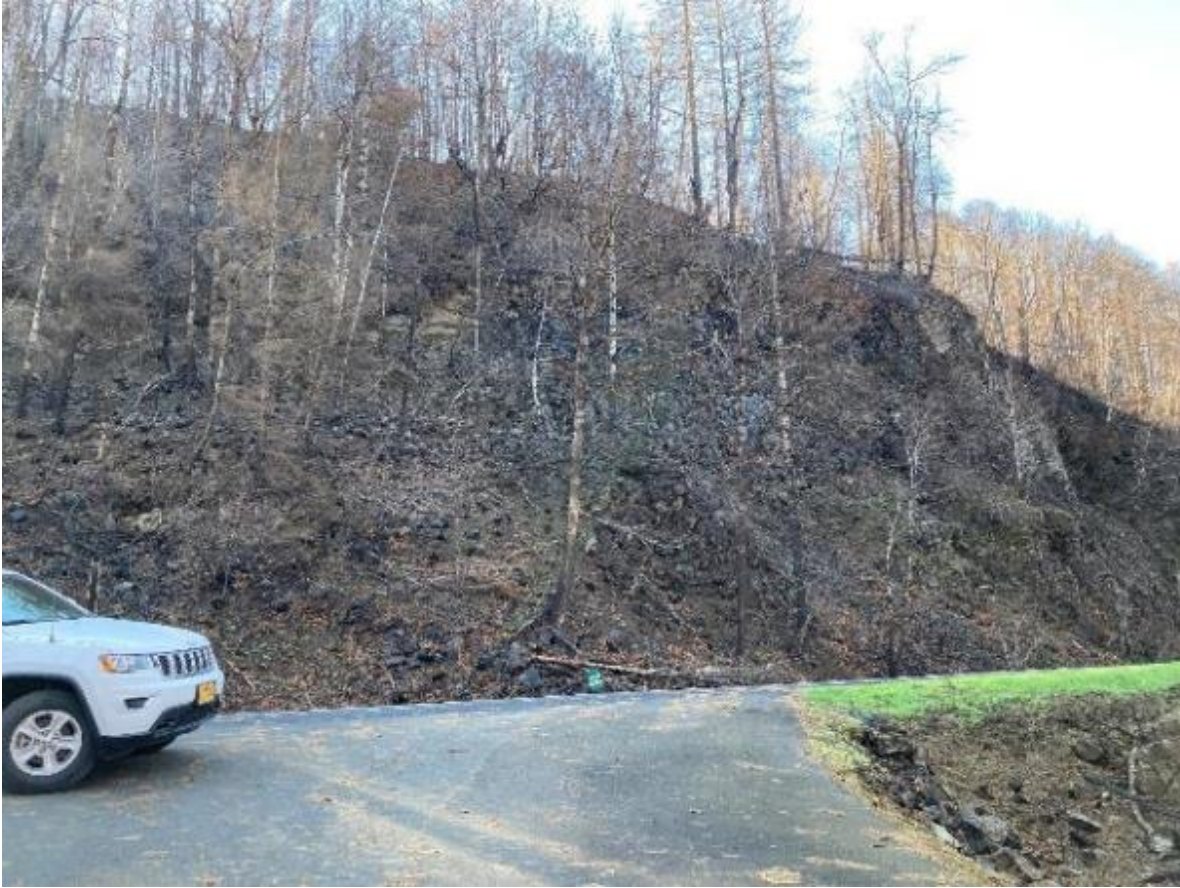
Photo 4: Rockfall hazards along North Fork Road (Marion County). Steep burned slopes on all roads in the fire area should be monitored. The vegetation of the slopes that was keeping the rocks on the slope is now gone. Loose rocks will fall during and after rain events.

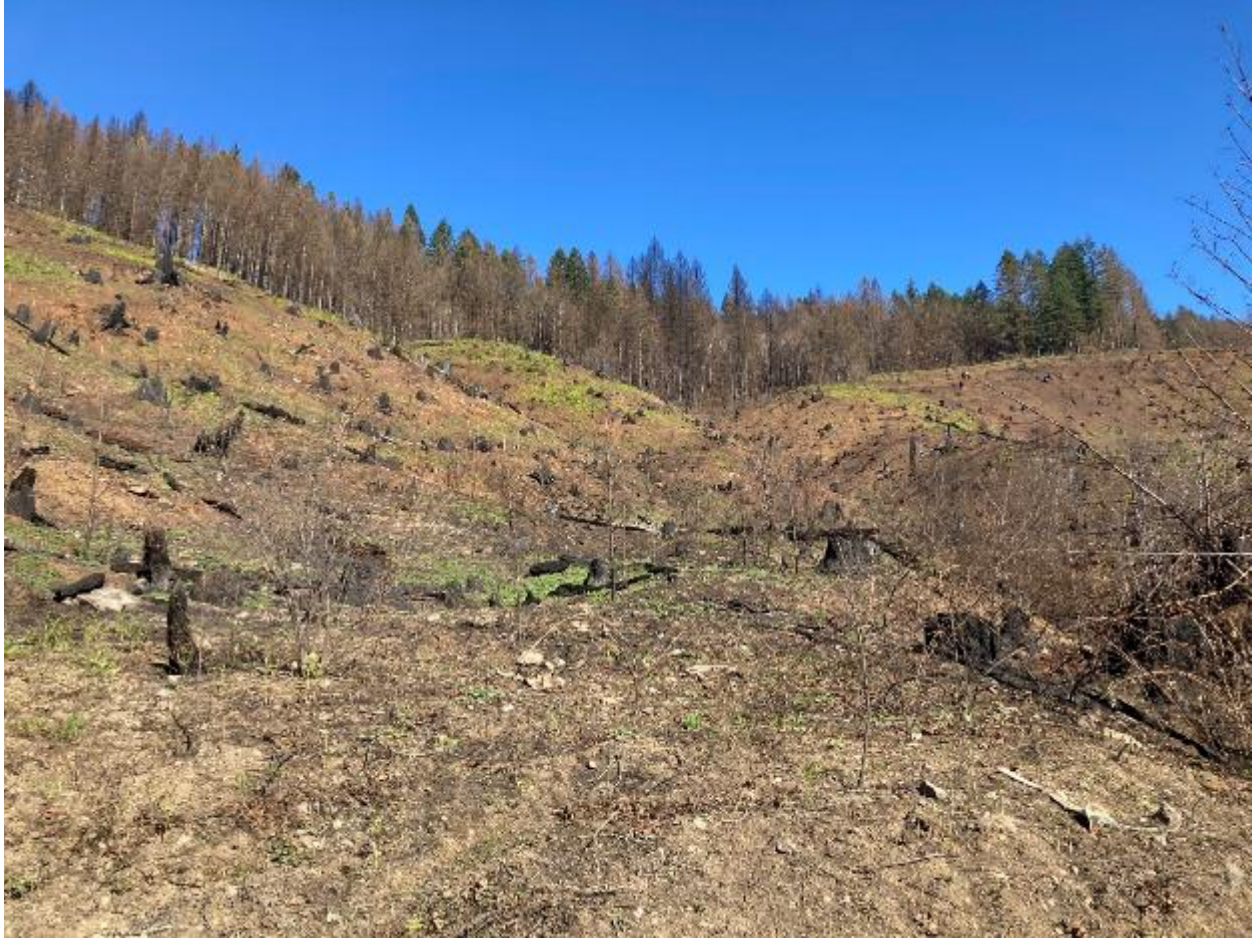
Photo 5: Clear cut slopes in the burned area along North Fork Road (Marion County). This area is an active landslide called “Bear Trap” landslide. During this assessment, drilling crews were installing slope inclinometers near the road to monitor landslide movement. A Hilfiker type retaining wall is supporting the toe of this slope below the road. Post fire debris flow hazard is high on this slope. Landslide activity would be expected to increase 3-5 years or sooner post-fire.
