Holiday Farm Fire

Erosion Threat Assessment/Reduction Team (ETART)
Extended Report

December 2020

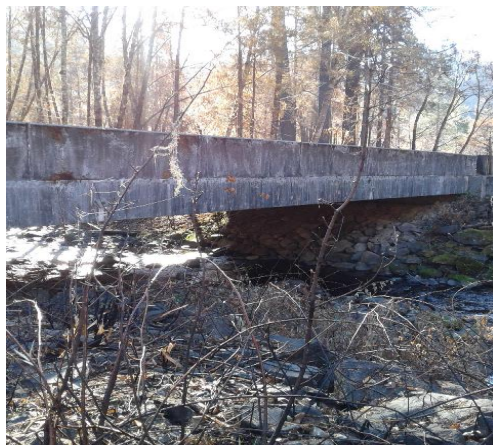
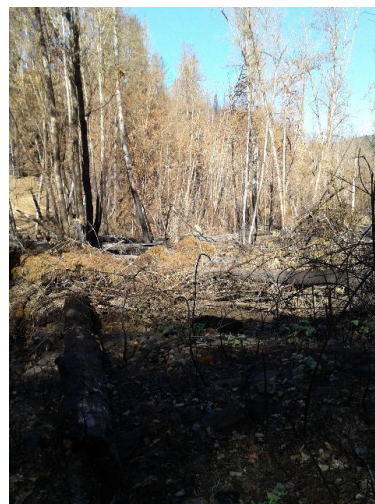
Lane County bridge #20457 is located over Simmonds Creek at MP 0.45. It is a pre-stressed concrete bridge constructed in 2005. This bridge is assessed as a very high risk as it is of high value and is in jeopardy of damage due to the fire damage up-gradient of the bridge. The bridge is located below a drainage that has moderate and high burn severity. Debris from the large watershed catchment above is highly likely to impact the footings of the bridge.

Up-gradient side of Simmonds Creek Bridge

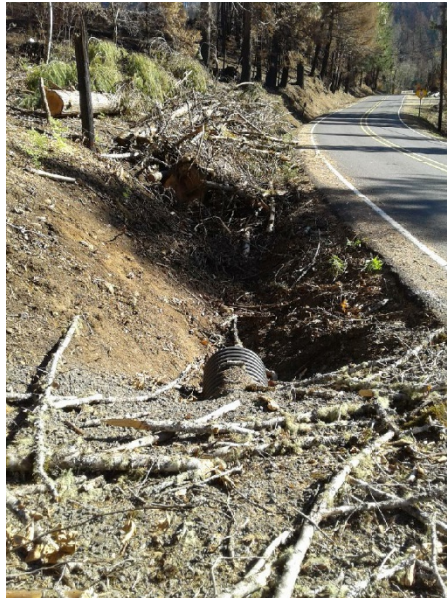
Findings: Blue River Drive is functionally classified as a Rural Minor Collector and was assessed as being at an intermediate risk level. This road provides access to the town of Blue River and to McKenzie High School. Because Blue River Drive is frequently used by the general public, the road should be a top priority for hazard mitigation. It is anticipated that cross drain culverts along the entire length of the road (MP 0.0-1.55) will see increased sediment delivery and woody debris to the culverts potentially plugging them and causing them to fail. There are approximately 40 culverts along 5.03 miles of road surveyed for potential treatment. Ditch lines along the length of the road are full of woody debris. Hazard trees are prevalent along the entire stretch of road.

Debris in ditch-line along Blue River Drive

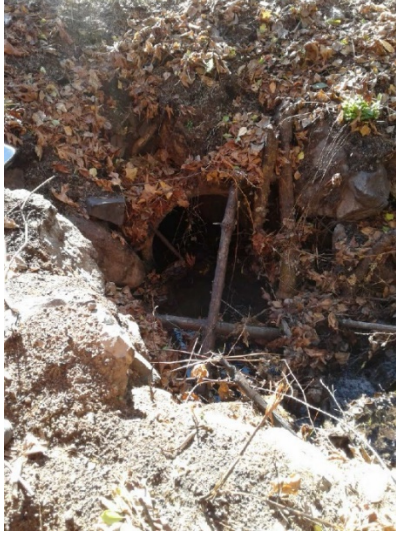
An 18 inch CMP cross drain culvert located at MP 1.61 is in jeopardy of failure due to the fire damage. The risk at this culvert was assessed to be very high due to the culvert being located at the bottom of a steep slope that has seen moderate and high burn severity. If the pipe were to become plugged and fail, the result would most likely wash out the road prism.

Cross Drain culvert along N. Gate Cr. Rd.

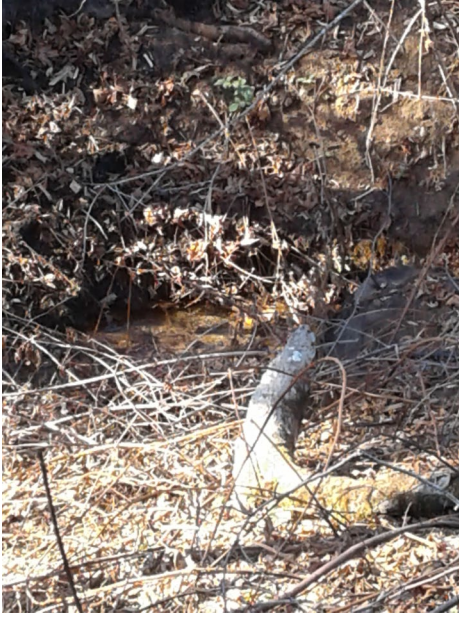
A 36-inch concrete cross drain culvert is located at MP 0.75 and is in jeopardy of failure due to erosion from the fire damage. This culvert under 15 feet of fill could result in a high consequence of failure if the plugged culvert washes out the road prism.

36-inch cross drain culvert

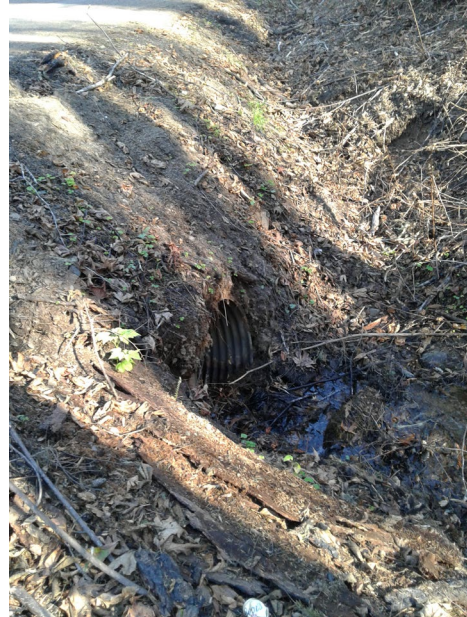
42-inch cross drain culvert

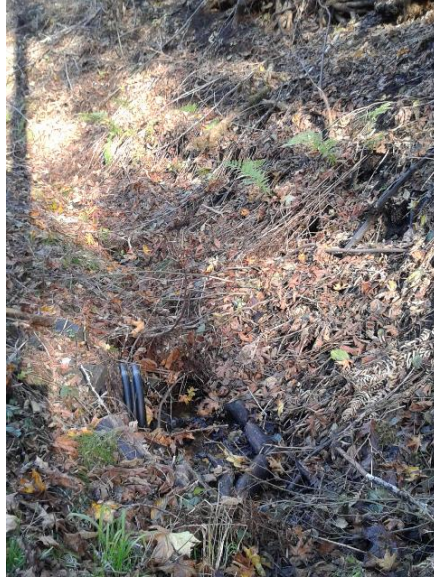
Cross drain culvert along Leashore Dr.

Proposed Remediation: It is recommended to have 1-2 people complete storm response for the road following significant rainfall events to ensure that the ditch and culverts are correctly functioning. Remove any hazard trees or woody debris that are in the roadside ditches or at inlets to all culverts along the entire stretch of road.

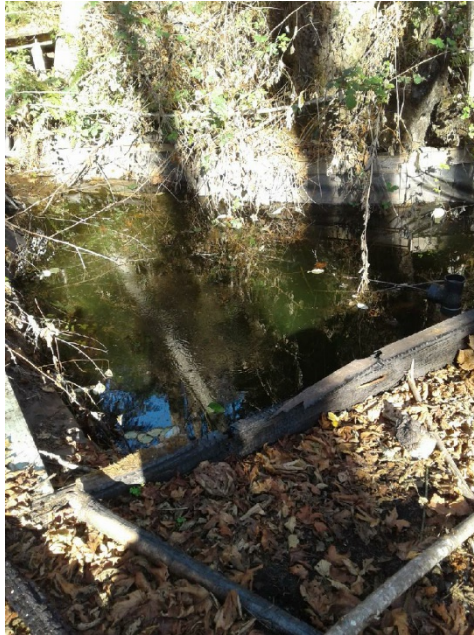
New 18" culvert with pond holding water up-gradient of culvert

The 18 in HDPE cross drain culvert should take high priority for treatment. It is recommended to remove the dam up-gradient of the culvert or to replace the wooden dam retaining wall structure. Investigation of ownership of the dam may be necessary prior to treatment.

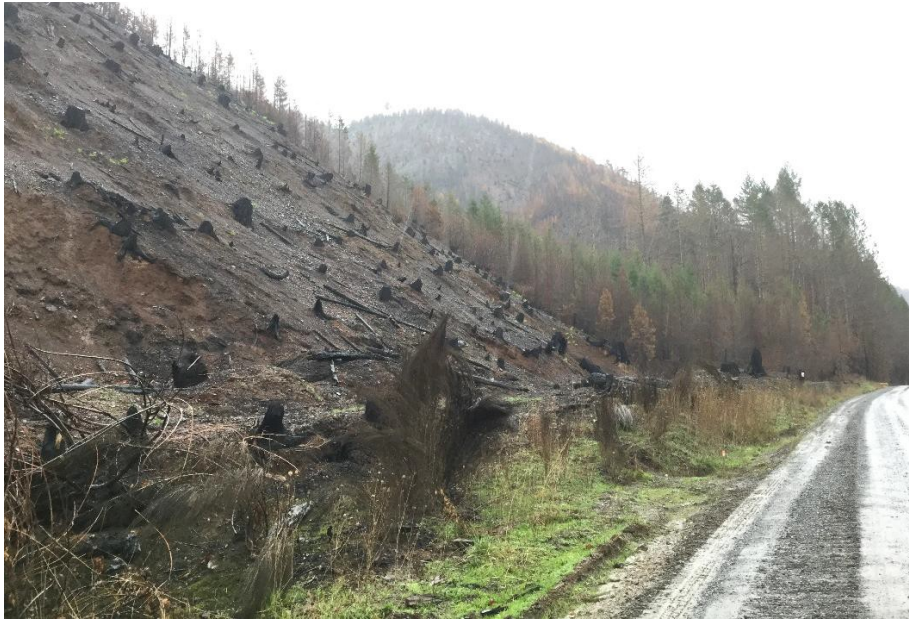
Above: Scotch broom (foreground) is highly resistant to fire and can fuel much more intense fires. It is common along forest roads and expands readily into disturbed and open habitat. Scotch broom is a threat to life and safety for nearby residents and impedes seedling establishment.
Quartz Creek Road

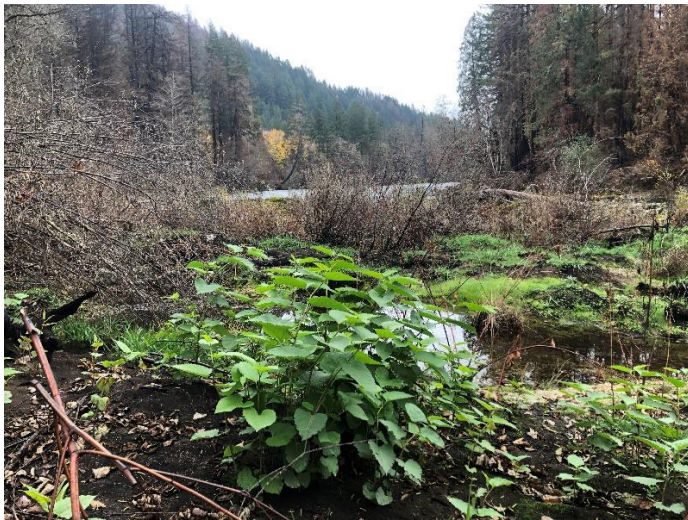
Above: Knotweed readily resprouts following fire in an otherwise healthy floodplain along the mid- reach McKenzie River (South Fork) (adjacent to several incinerated homes). Knotweed further exacerbates current erosion, soil loss and sedimentation challenges since it lacks fibrous roots and goes dormant in the winter months. It also resprouts from small fragments and can easily be transported via waterways.

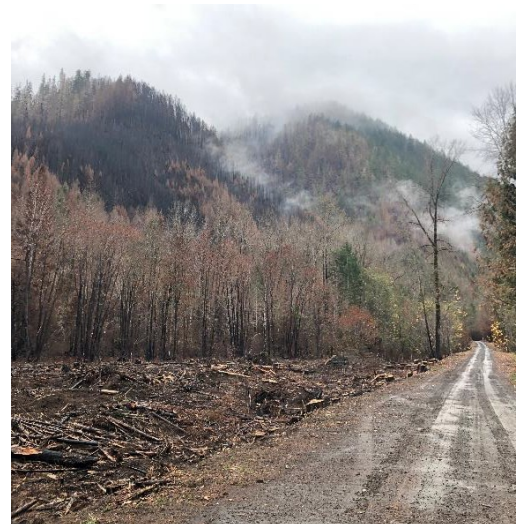
Above: Forest roads like Quartz Creek and NF-805 require roadside treatment to manage critical weed source populations such as false brome and herb Robert (both are very limited but are poised to explode into high burn severity areas).

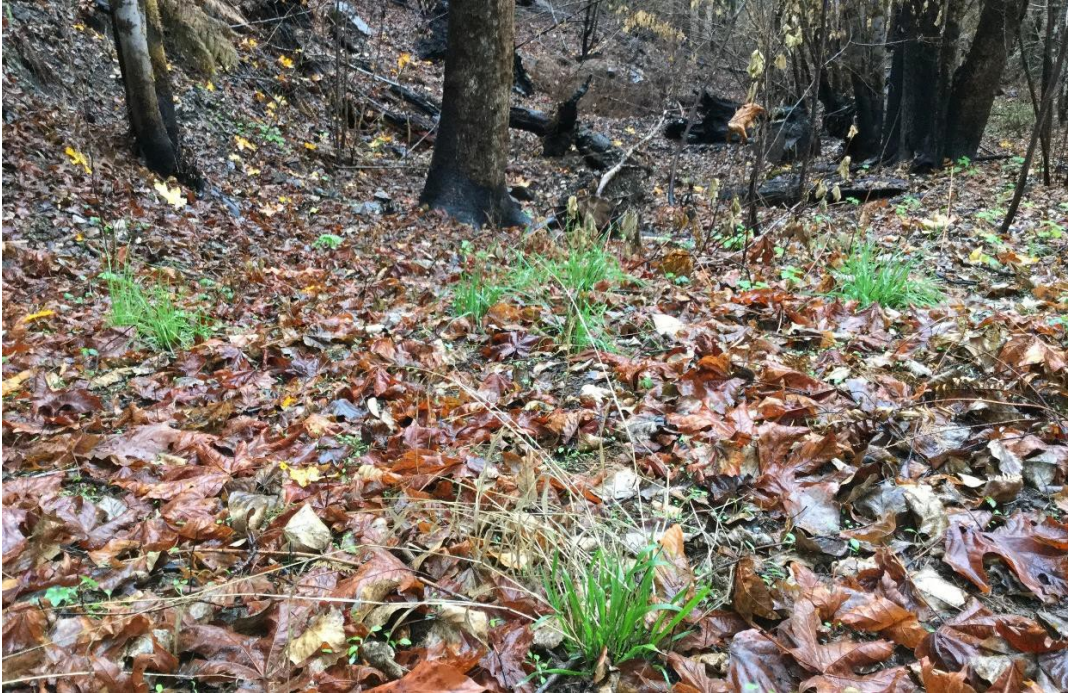
Above: False brome populations are currently only scattered along road ways, and present at public access points such as boat ramps. If they aren't managed quickly they threaten to quickly dominate the landscape. False brome drives more intense fires by building up layers of dead vegetated plant matter and spreads easily by seed in corridors such as here on NF-805, adjacent to Quartz Creek Rd.

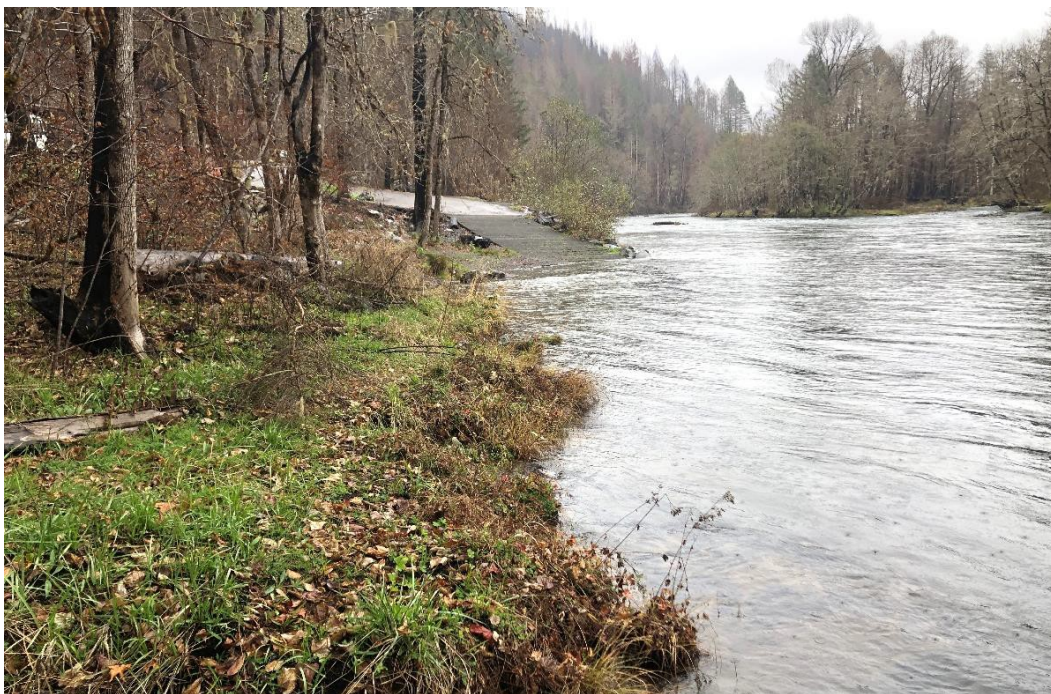
Above: False brome is also present in other concerning locations such as the riparian floodplain at Silver Creek Boat Ramp, where it could easily be spread by recreation users.

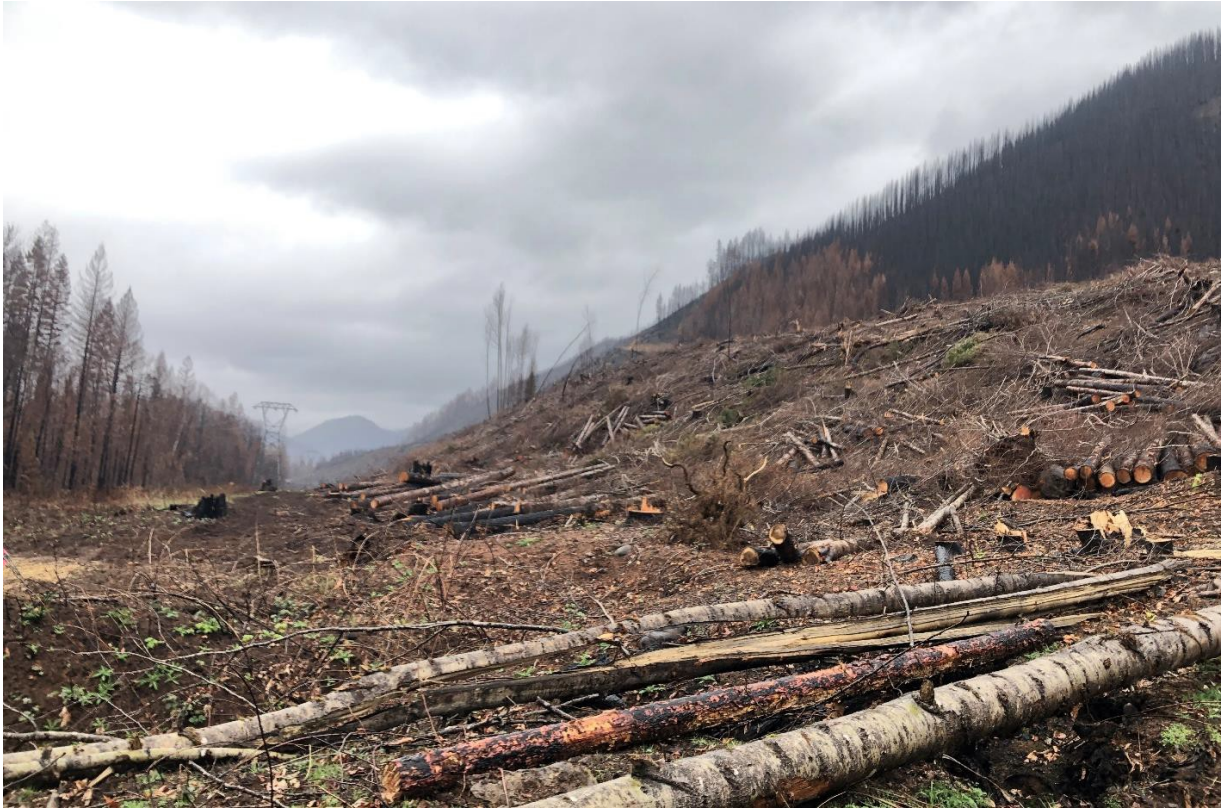
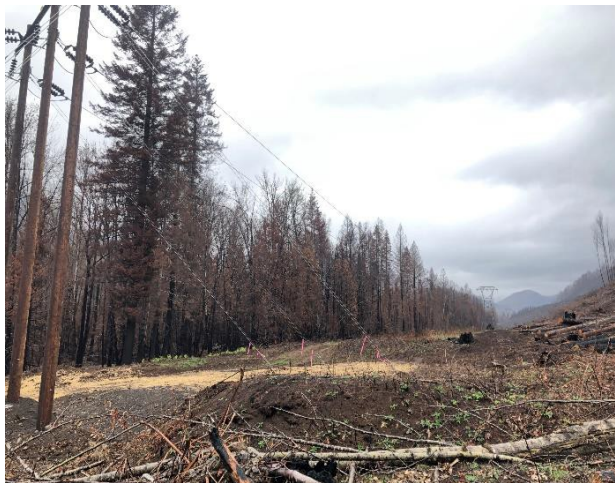
Above and Lower Left: Spotted knapweed thrives in the high power utility corridor and is expected to be a source population for weed spread in adjacent burned areas with high mortality. Any time vehicles or equipment enter an area they may bring weeds.

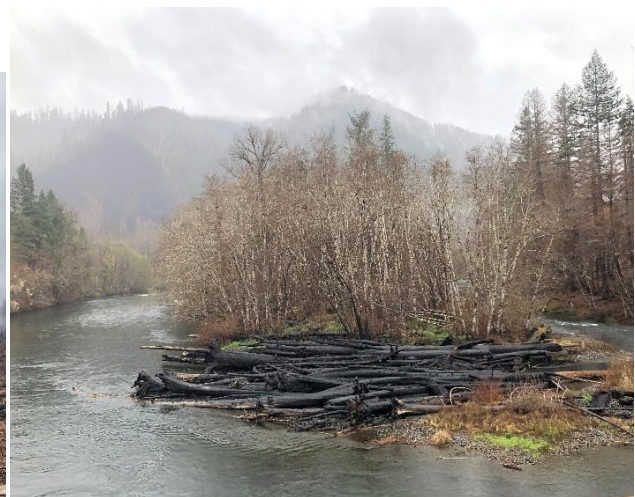
Lower Right: Debris flows carry more than sediment and logs—they also carry seeds.

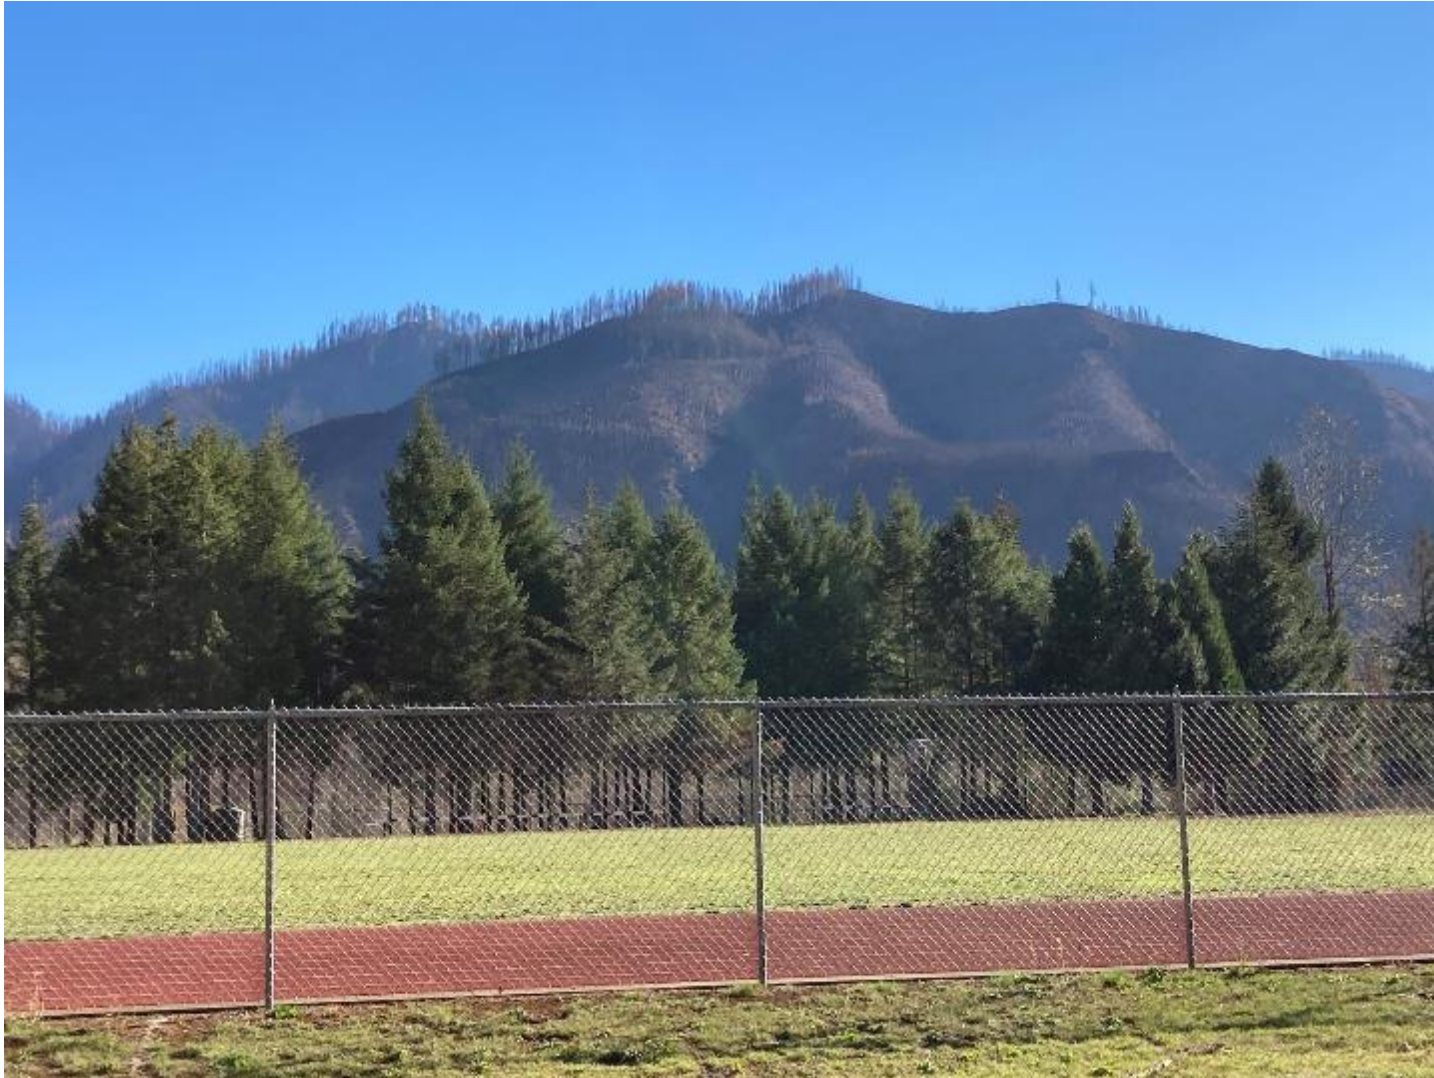
Photo 1: Moderately to highly burned hills east of Blue River with high debris flow hazard. Expect increased sediment laden water runoff and possible debris flows in drainages that do not regularly receive much water.

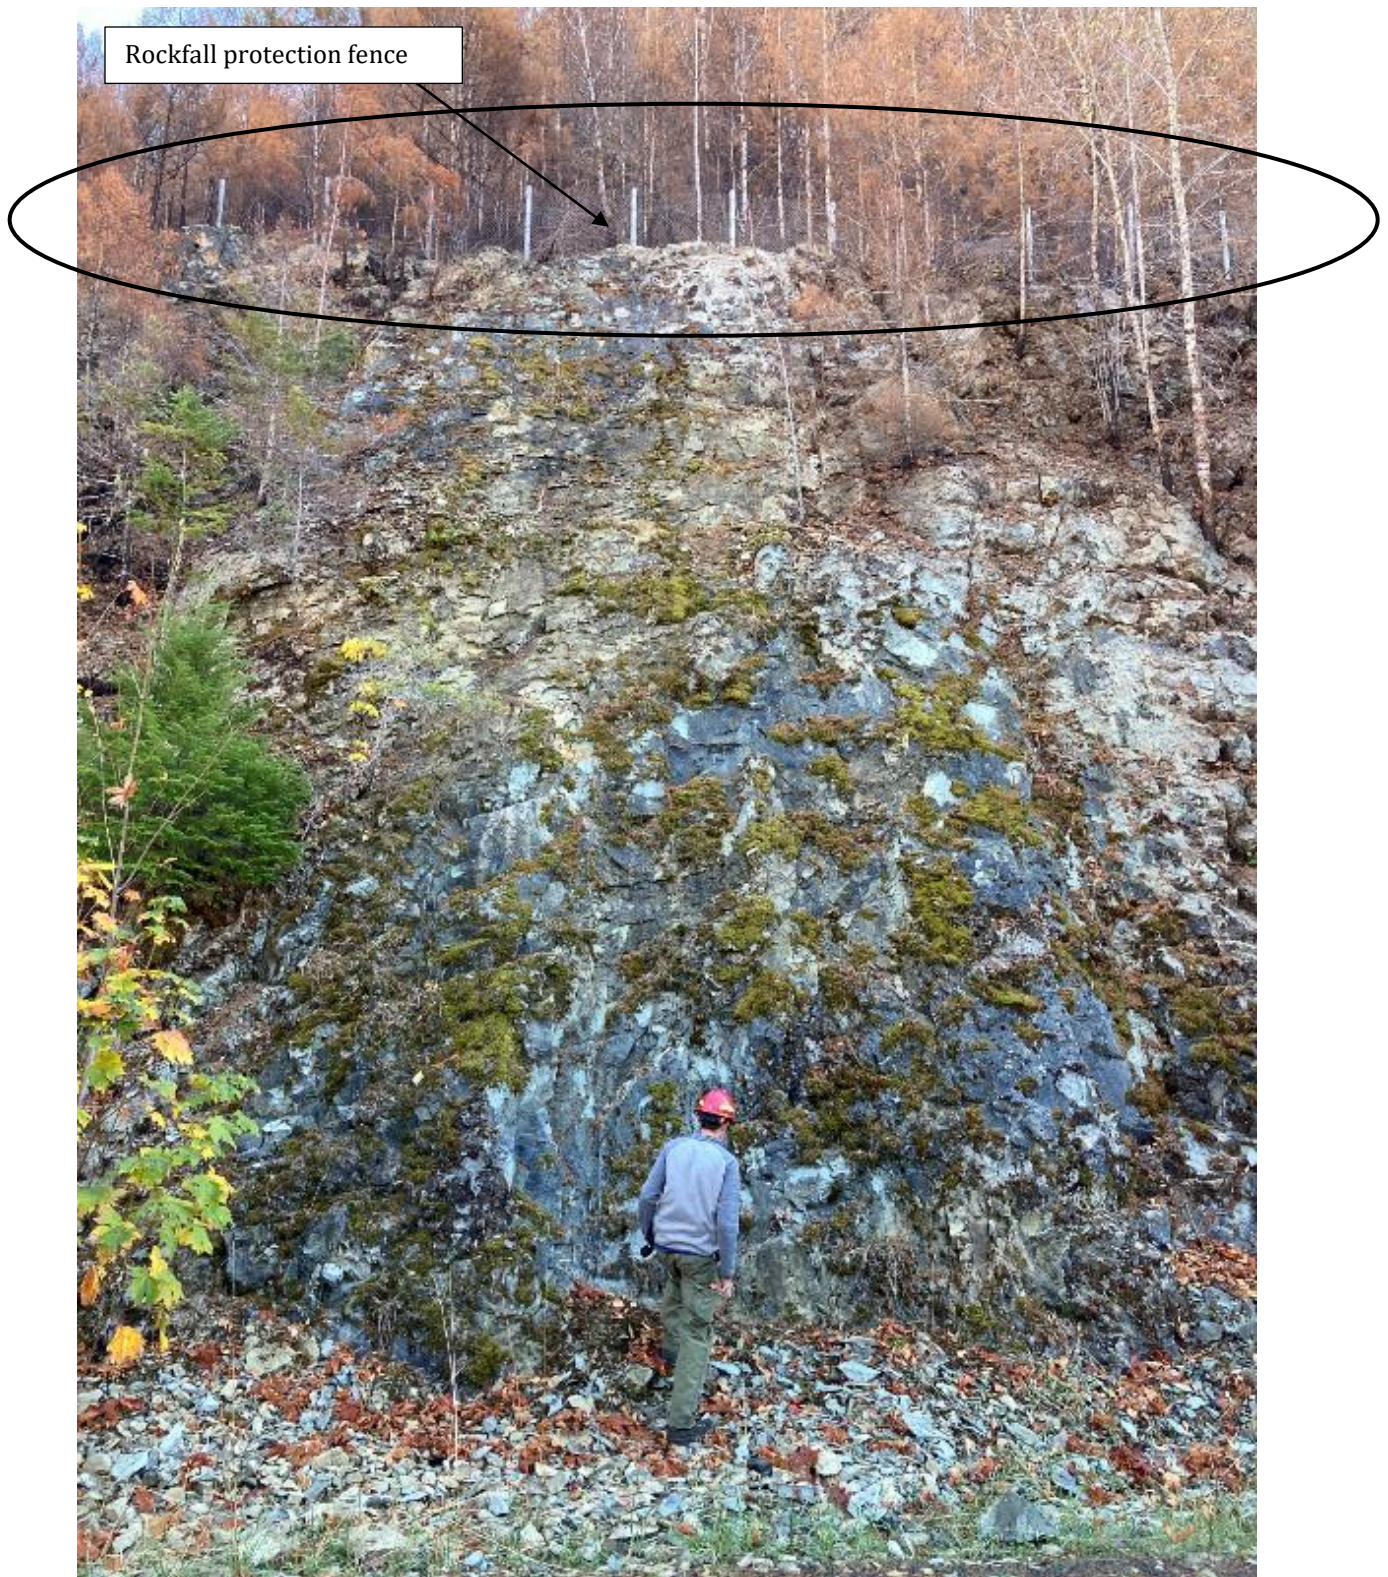
Photo 2: Rockfall hazards at the Blue River Dam facility. Very steep burned slopes burned above and along cliffs adjacent to the structure. There is a rockfall protection fence approx. 30 ft. above access road. The fence needs to be maintained to be functional. Loose rocks will fall during and after rain events.

Recommendations: Repair and maintain current rock safety structure. Fence to catch falling rock from slopes above service road is damaged or at capacity in many places. Fencing above emergency spillway has failed in several spots.

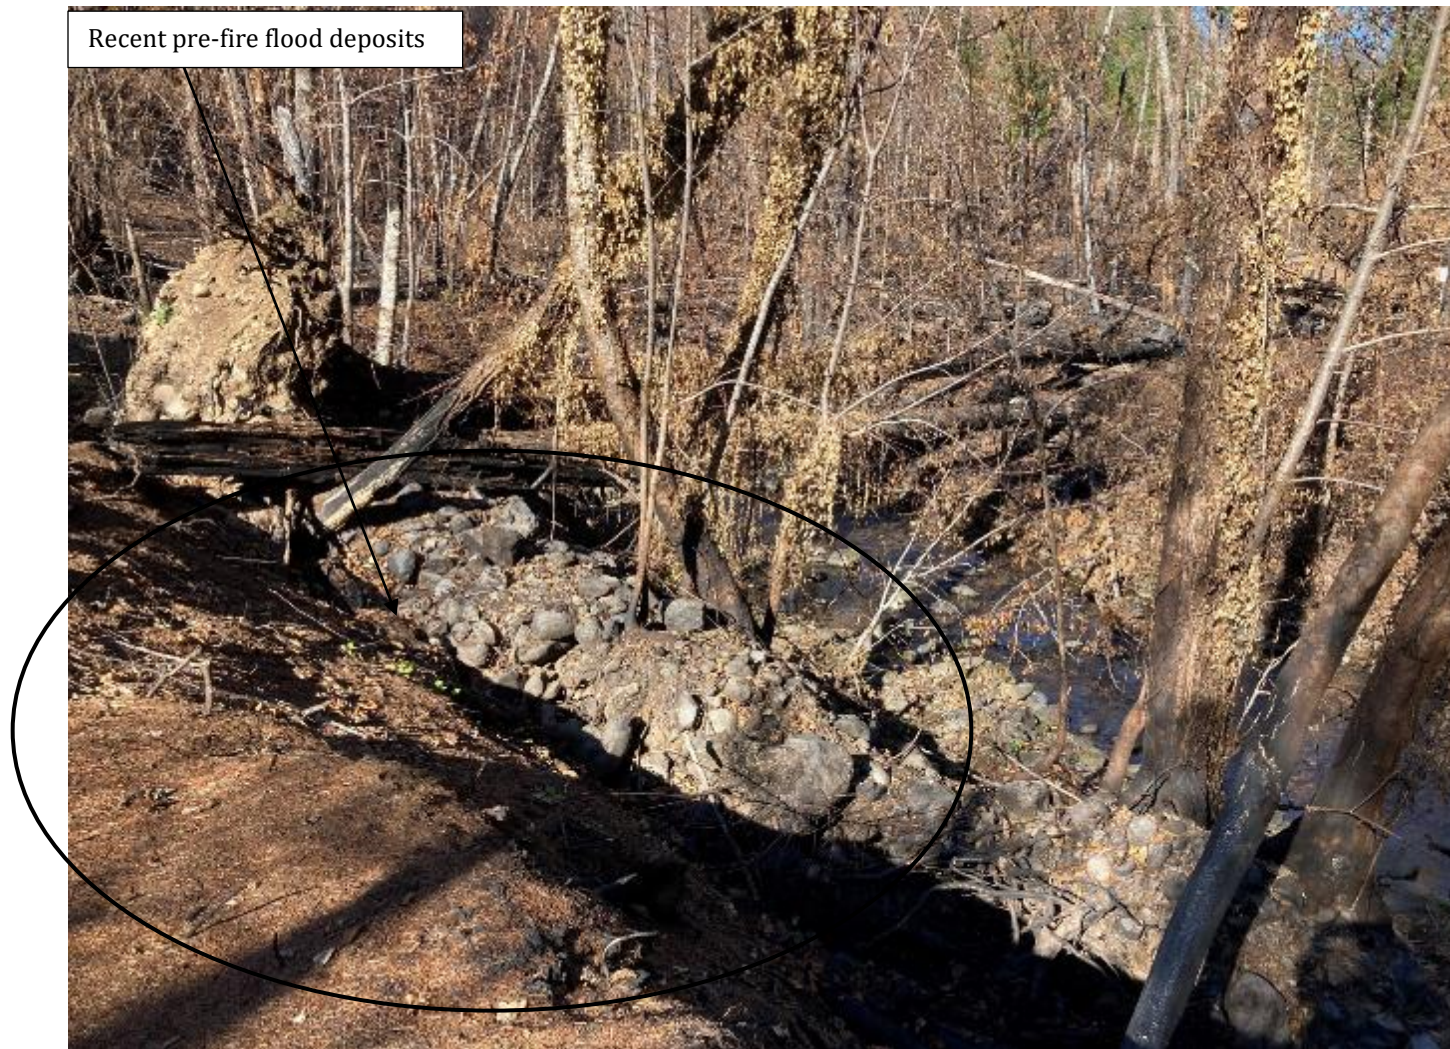
Photo 3: Simmons Creek at Lucky Boy Road just upstream of bridge. Simmons Creek was not modeled by the USGS debris flow model because its drainage area is over 8km. The small upstream tributaries that contribute to Simmons Creek have a high to very high likelihood of a debris flow. This would increase the sediment load and flood this location.

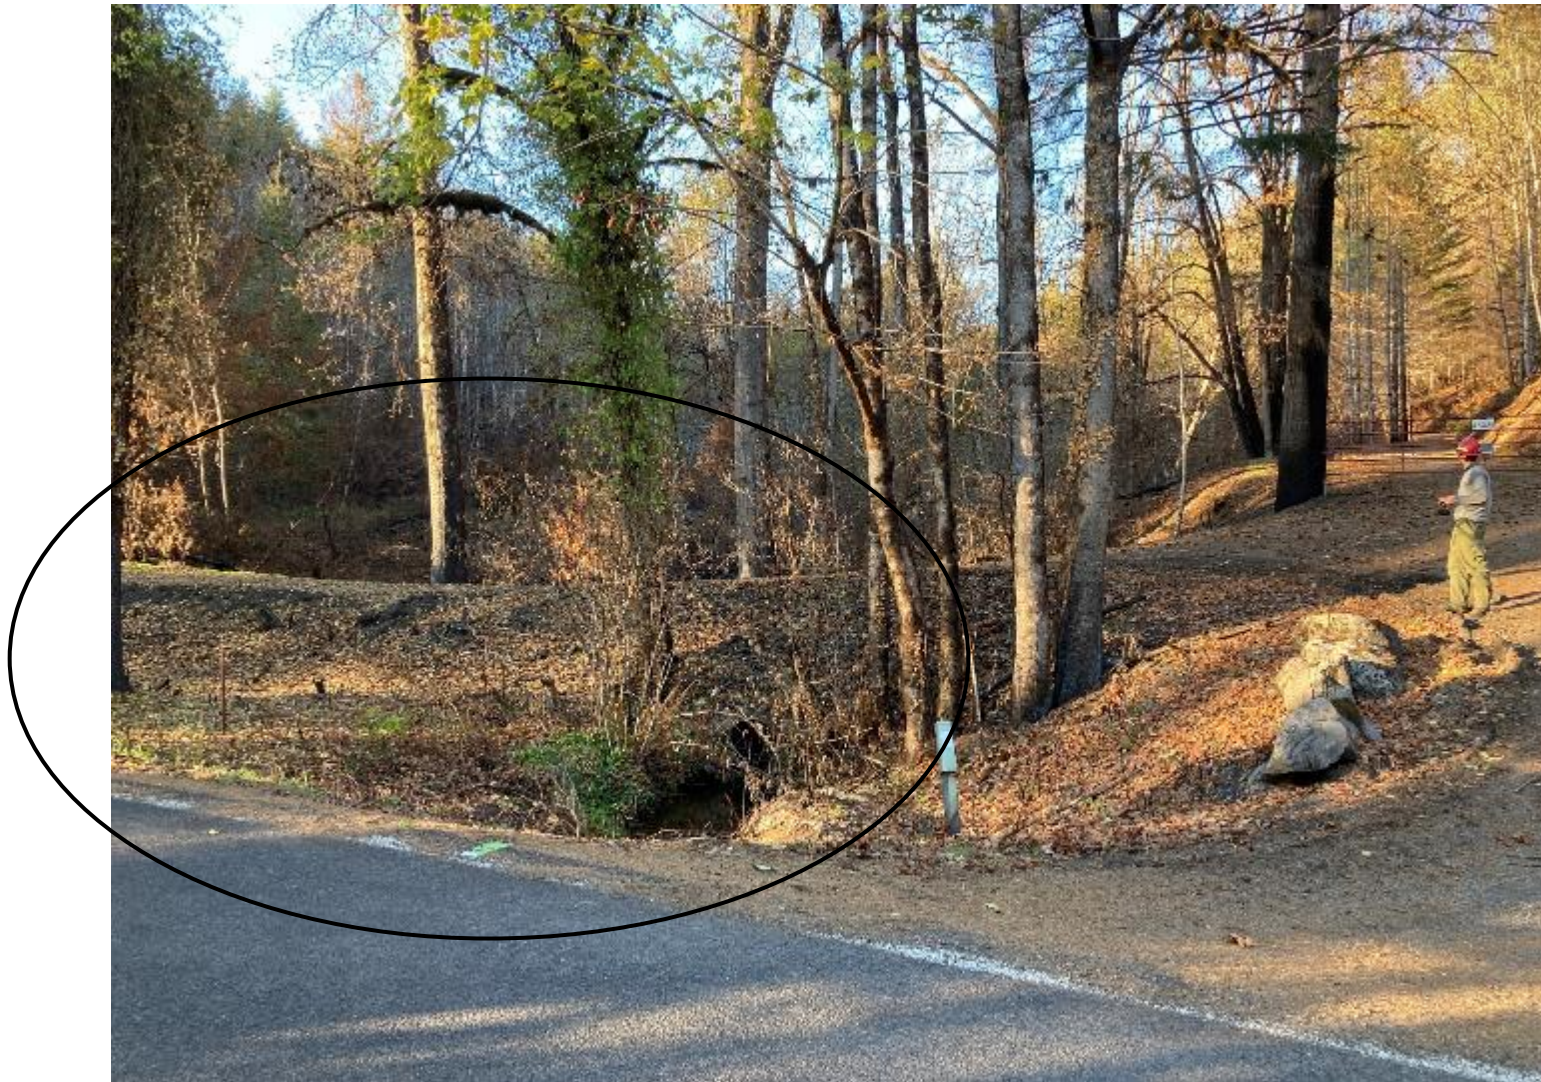
Photo 4: Drainage along Gate Creek Road (Vida) with moderate debris flow hazard. This is a tributary to Gate Creek on private land. The channel is blocked by a driveway with an undersized culvert. Landowner stated that this channel does not regularly receive much water but did note that the 1996 floods did over top the driveway and diverted down the road. Expect increased sediment laden water runoff and possible debris flows in drainages that do not regularly receive much water.
