Beachie Creek Fire

Erosion Threat Assessment/Reduction Team (ETART)
Summary Report

December 2020

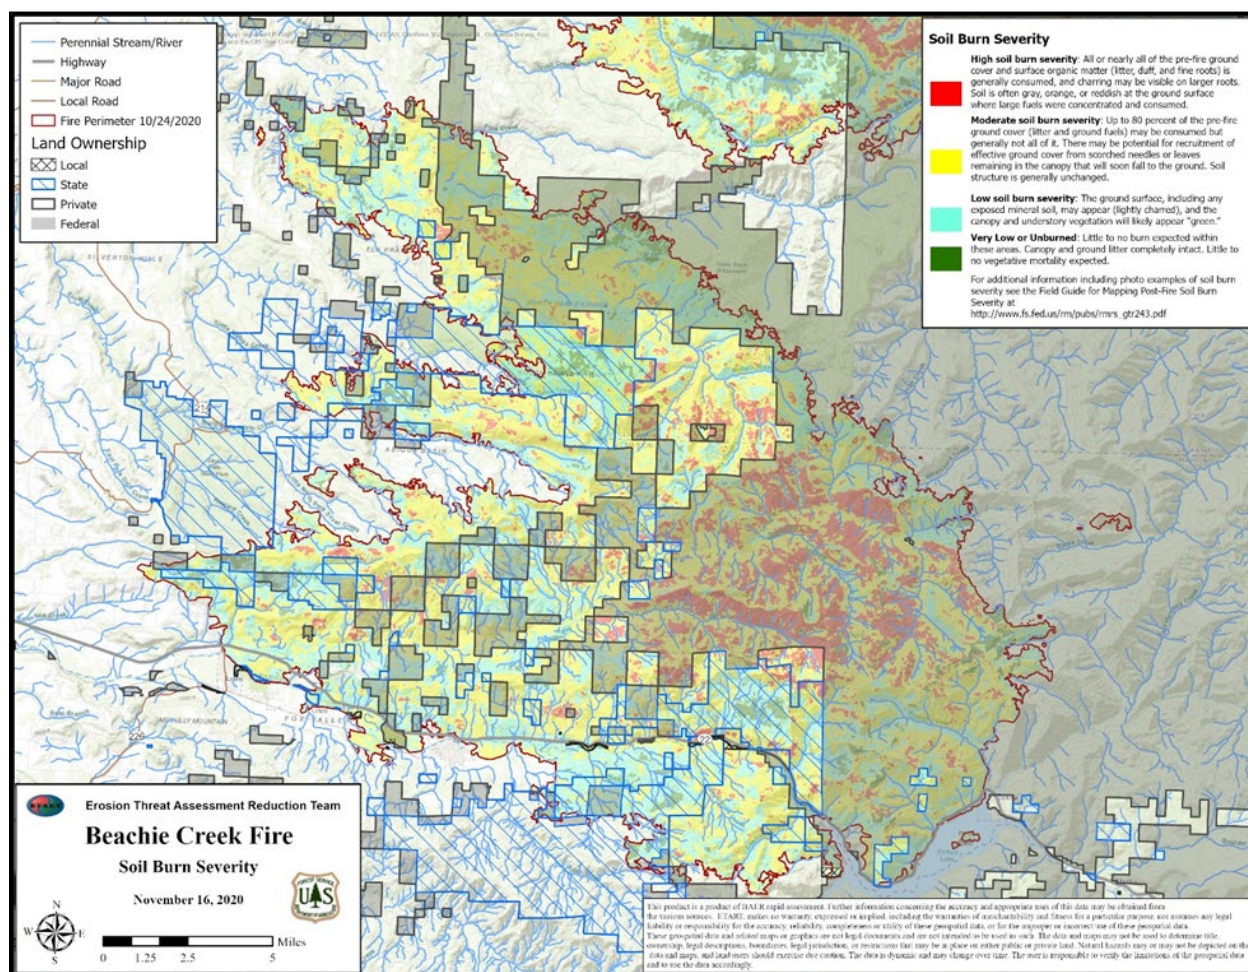
Figure 3. Soil Burn Severity – Beachie Creek Fire

Prior to the ETART effort, the Forest Service produced a Soil Burn Severity (SBS) map as part of their Beachie Creek BAER Assessment (Figure 3). The Forest Service SBS mapping did not field-validate soil conditions on private or state lands. The ETART soils team completed soil burn severity validation on state and private lands with on-the-ground data collection and visual observations (Table 6).

The areas of high SBS occurred primarily in the higher elevations on ridgelines and peaks. Lower elevations and riparian areas were observed as being unburned or low SBS due to the heterogeneity of vegetation and soil moisture content. Moderate and high SBS was consistently observed on south facing slopes, such as the south facing slope of Elkhorn Mountain on Beachie Creek. South facing slopes are generally drier and therefore ground fuels were less resistant to fire.

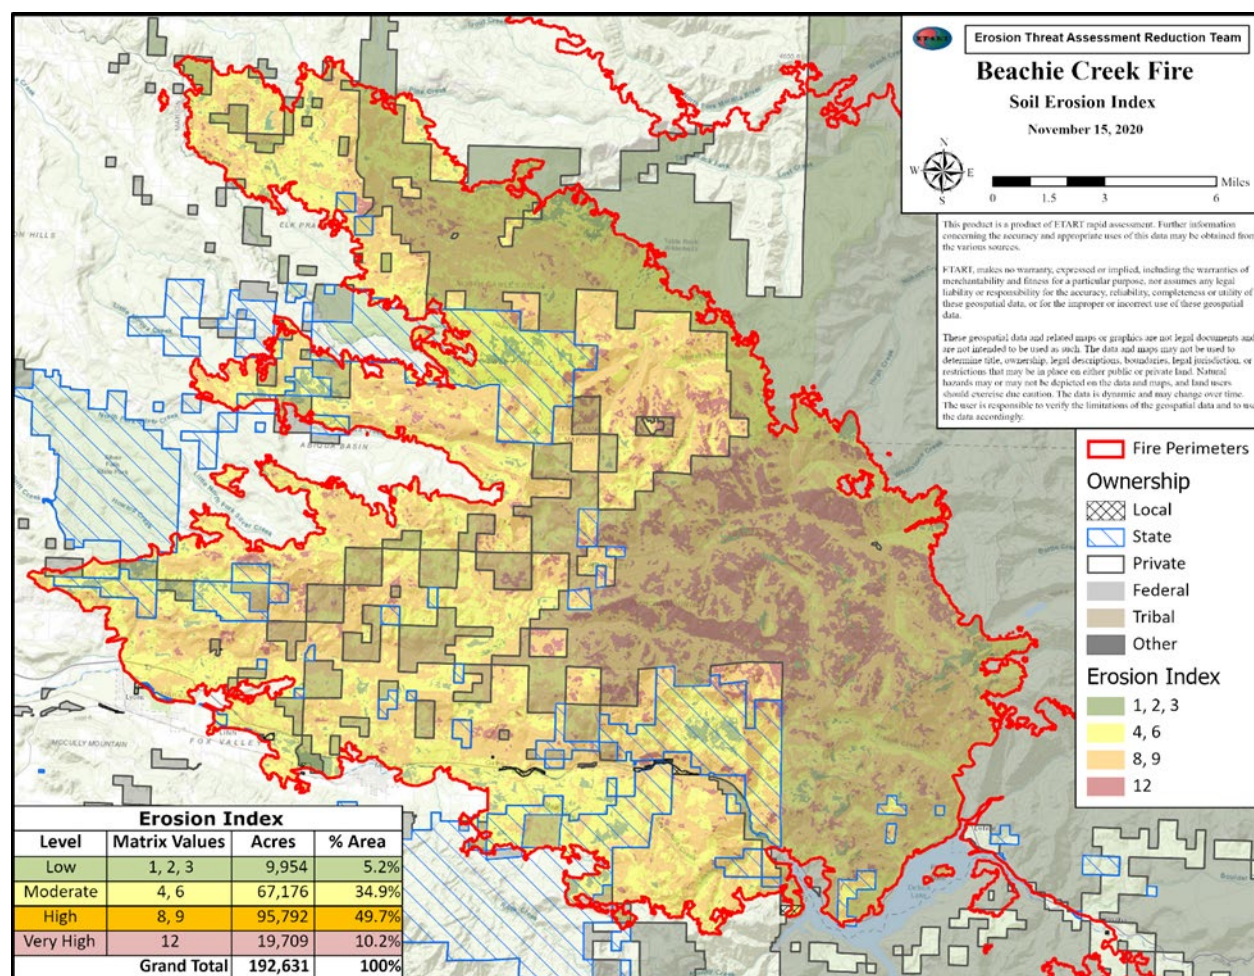
Figure 4. Soil Erosion Index – Beachie Creek Fire

Figure 4 displays the spatial distribution and acres by SEI for the area burned by Beachie Creek Fire. The matrix values in the map table represent combinations of inherent SEI with SBS. The analysis estimates 85% of the burned area has increased potential for accelerated soil erosion. The very high SEI is generally attributed to over-steepened slopes where SBS has minor influence to change soil erosion.

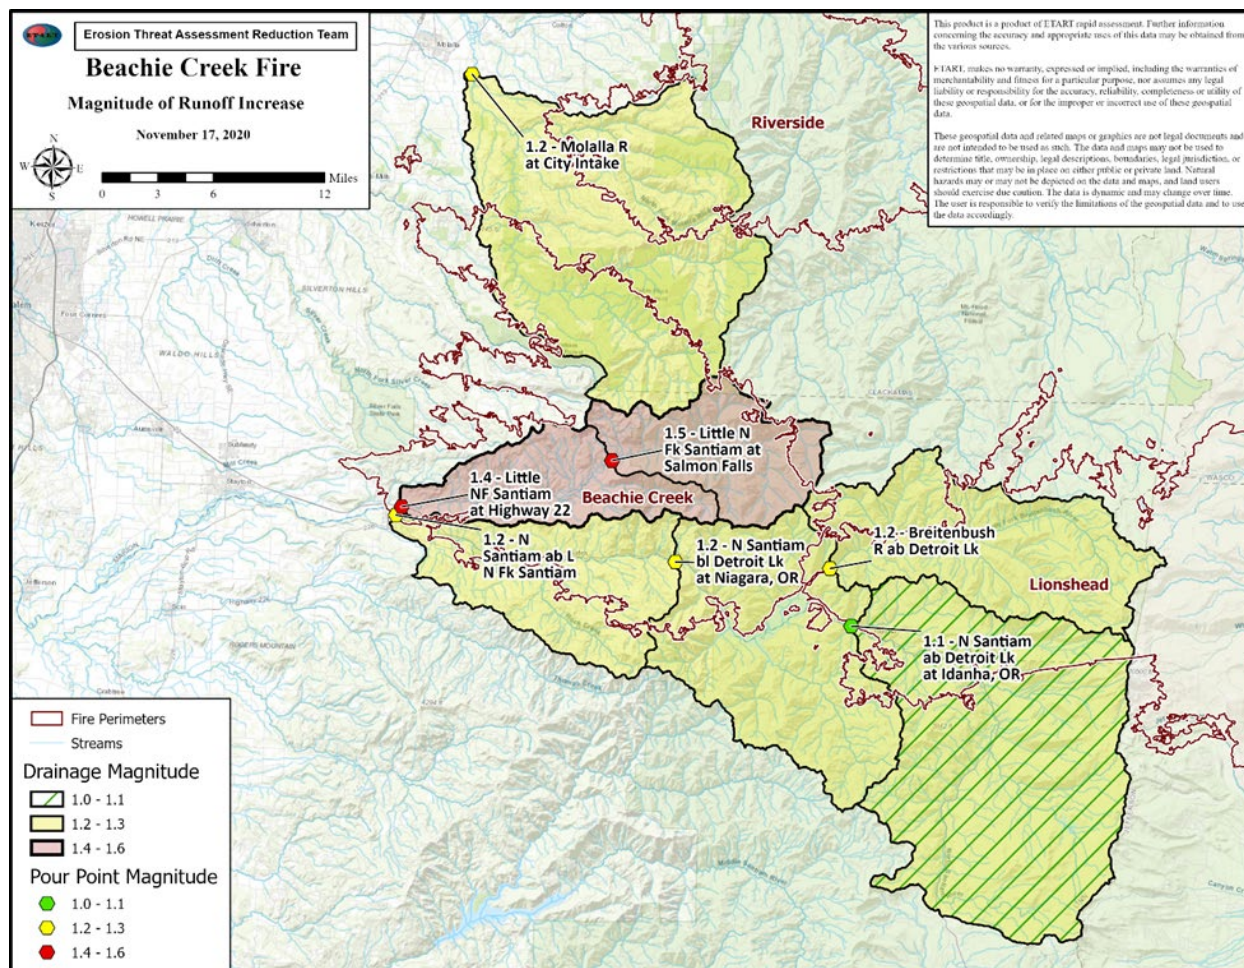
Figure 5. Watershed Response in Runoff Magnitude Increase – Beachie Creek Fire

Regional regression equations were used to estimate pre- and post-fire peak flows. Relative increase in 5-year post-fire peak flows is expected to be largest in the Little North Fork Santiam watershed where over 94% of the watershed burned. The Little North Fork Santiam River at Salmon Falls has a predicted increase in peak flow of 1.6 times the pre-fire peak flow magnitude. The elevated peak flow response is due to the large portion of moderate or SBS in a relatively smaller watershed. In contrast, the greatest increase in magnitude of post-fire peak flows in any other subwatershed is 1.2 times the pre-fire peak flow for the 5-year recurrence interval (Figure 5).

For areas within the Middle North Santiam River watershed, the regional regression equations do not factor in alterations to hydrology due to Detroit Lake and Big Cliff Reservoir operations. The largest tributary within this watershed, Rock Creek, remained largely unburned. Burned areas within the watershed include smaller tributaries such as Mad Creek and Sevenmile Creek, as well as the smaller, steep northern slopes draining into the middle portion of the North Santiam River. Although the magnitude of peak flows for streams within burned areas are projected to increase, the North Santiam River below Detroit Lake and Big Cliff Reservoir are designed to handle scheduled releases of much greater magnitude. Risk associated with burned areas downstream of the reservoir system
