Archie Creek Fire

Erosion Threat Assessment/Reduction Team (ETART)
Extended Report

December 2020

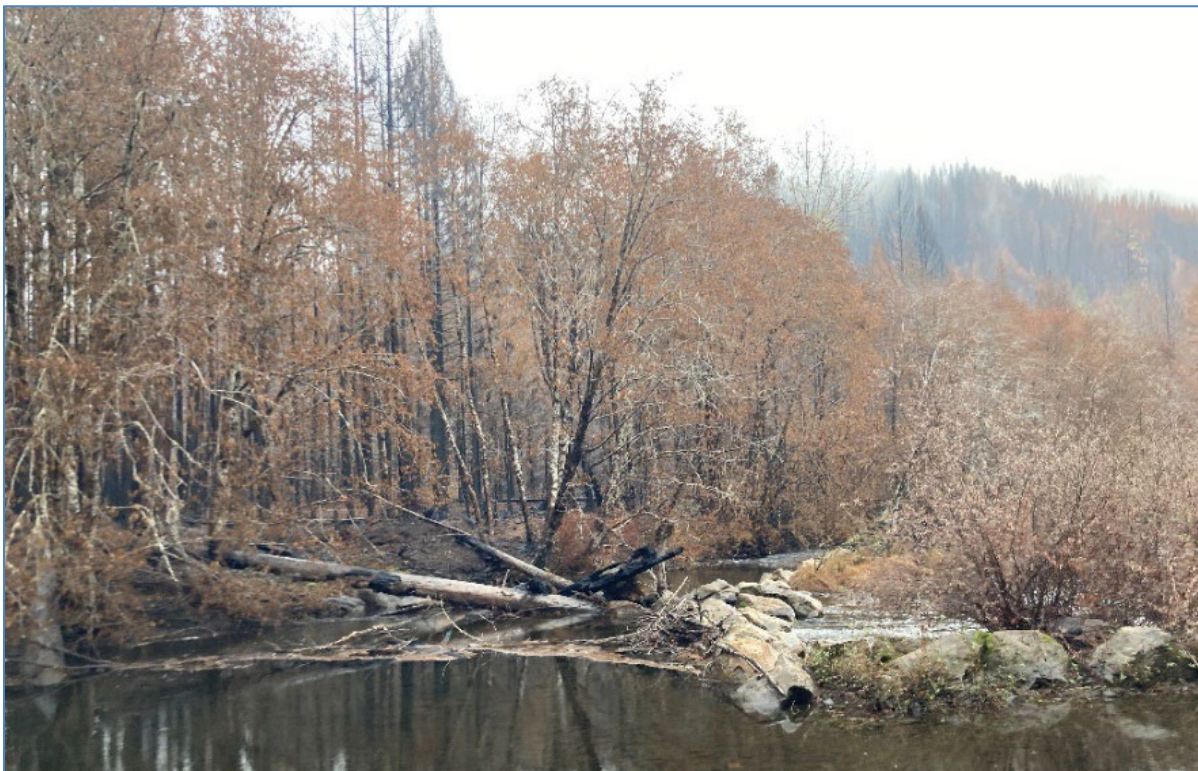
Burned areas along Rock Creek, depicting little remaining understory and high mortality of riparian hardwoods.

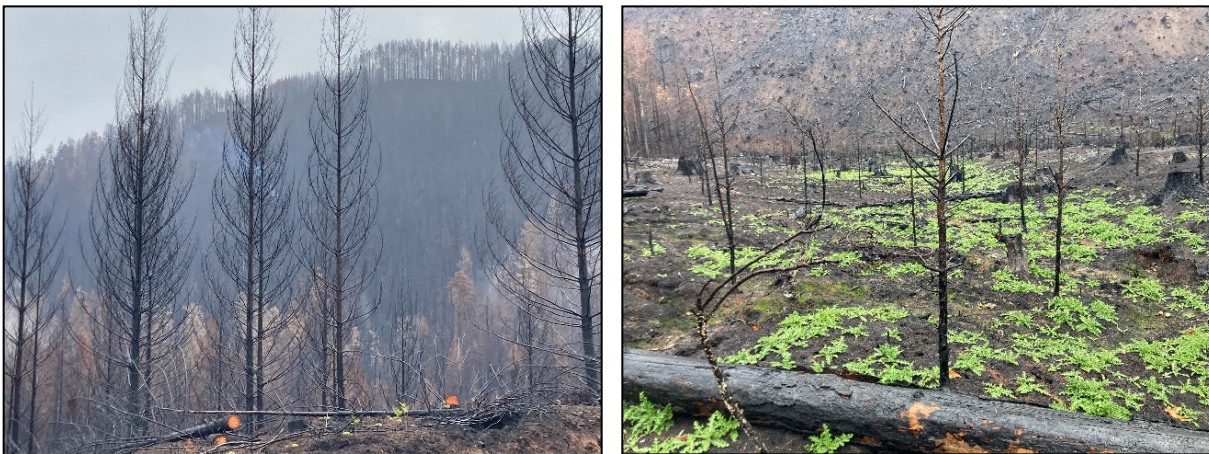
100% tree mortality and salvage logging operations (left) and rapid regeneration of Canada thistle in burned area (right) both within the Rock Creek watershed.

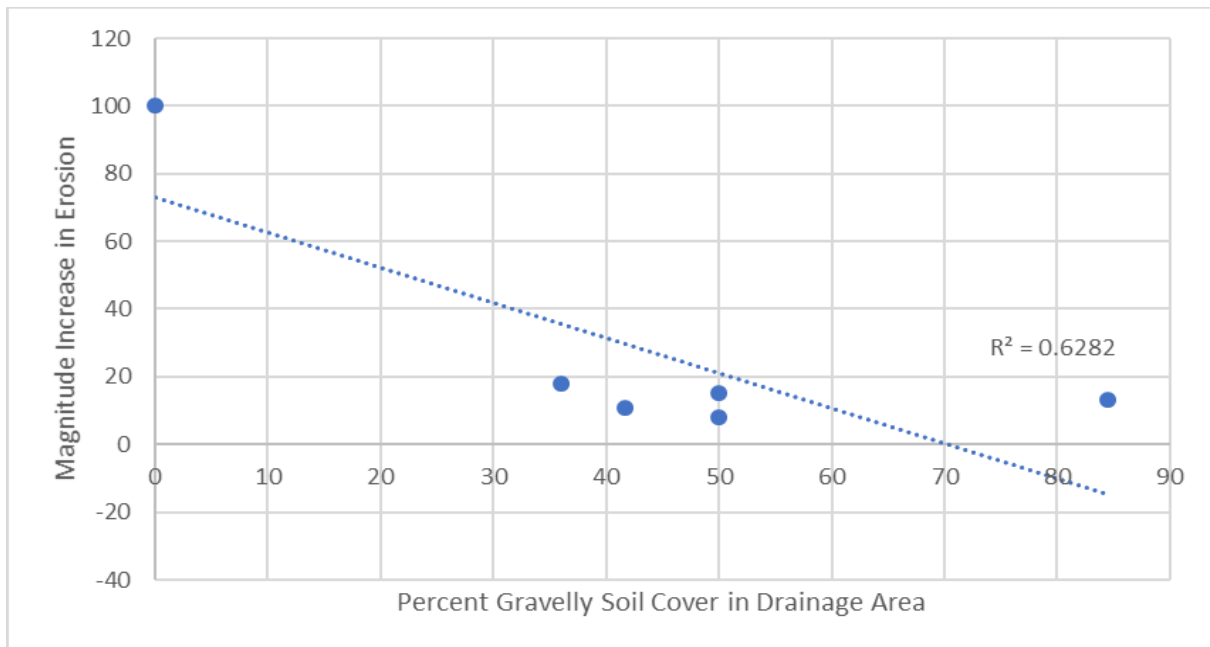
There appears to be a linear relationship between magnitude of increase and percent cover of gravelly soils in each drainage area. A plot of magnitude of increase in erosion versus percent cover of gravelly soils for each drainage was created and a linear regression was performed. The generated linear model has a r-squared value of 0.62819. Ideally, this regression would be done based on a greater scope of data, but this investigation is limited by time and other resources.

Figure 4. Plot of magnitude increase in predicted erosion versus percent cover of gravelly soil in drainage area.

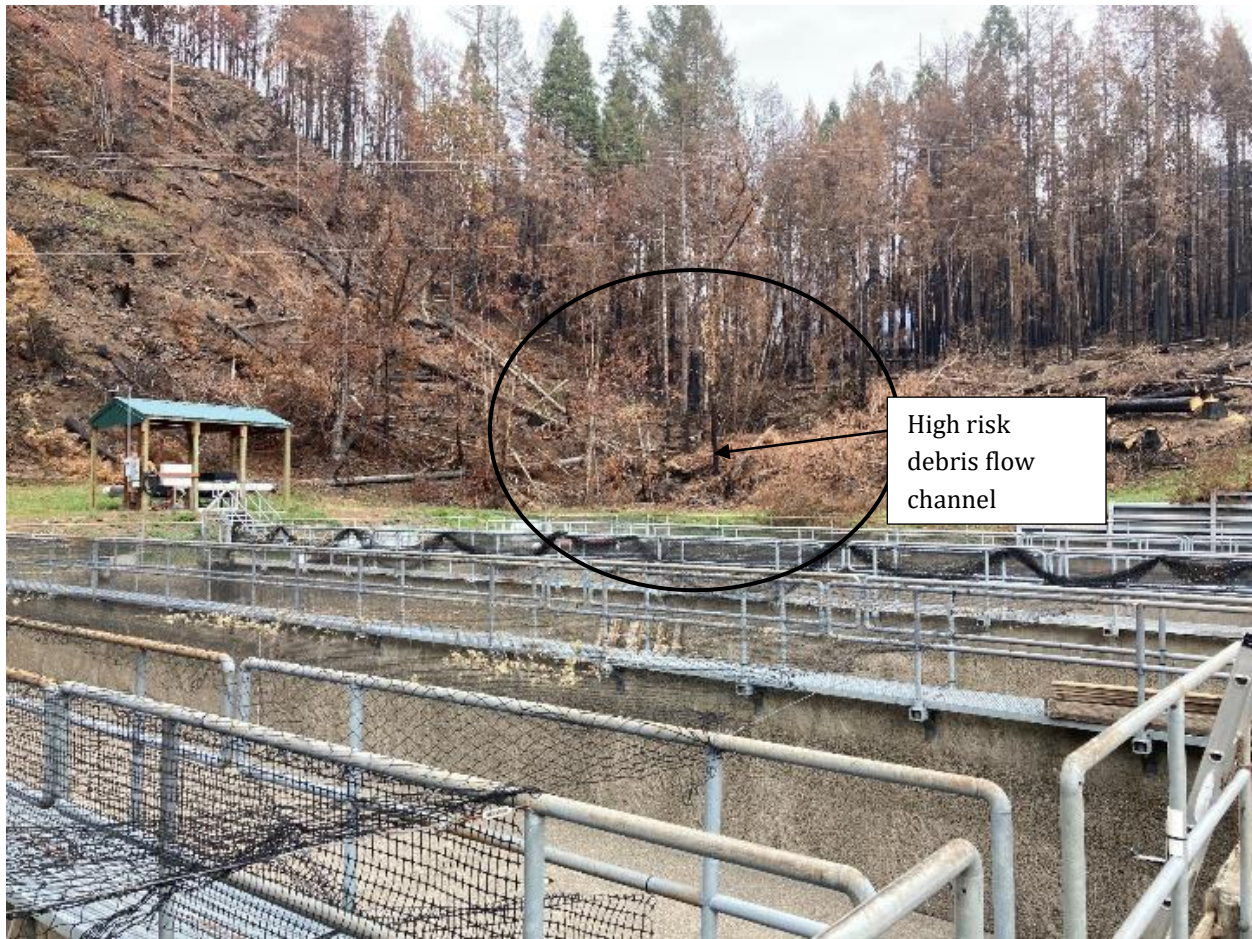
Very High risk to property at Rock Creek Fish Hatchery and at Rock-ed Outdoor Education Center from debris flows and landslides, as well as logs, debris and sediment flow into hatchery. Facilities and structures located on values located in floodplains, debris flow paths or depositional zones. Steep slopes directly adjacent to hatchery; and outdoor education center property and the hatchery is located on toe of active landslide and within in deposition zone of debris flows. There is a high mortality of trees mortality upstream, steep slopes with debris flow hazard increases potential for damage, but unlikely to be total loss. A potential threat is clogging of water intakes from increased loading of sediment and large wood (e.g., Rock Creek Fish Hatchery).

Photo 1: Rock Creek Hatchery and Rock-Ed education center are at high risk of possible debris flows deposition from channel entering the north side of the facility. Loose rocks will fall during and after rain events.

Recommendations: Close facilities, clean debris and logs as needed and consider berms/debris diversion structures. Inform county Emergency Management, use hazard warning signs and early warning system/weather alerts.

Recommendation: For protection of water intakes, increase frequency of inspection and debris removal, and outreach to the private landowners with water intake systems to increase awareness of the potential threats and recommended mitigations. Clean debris and logs as needed; consider berms/debris diversion structures.

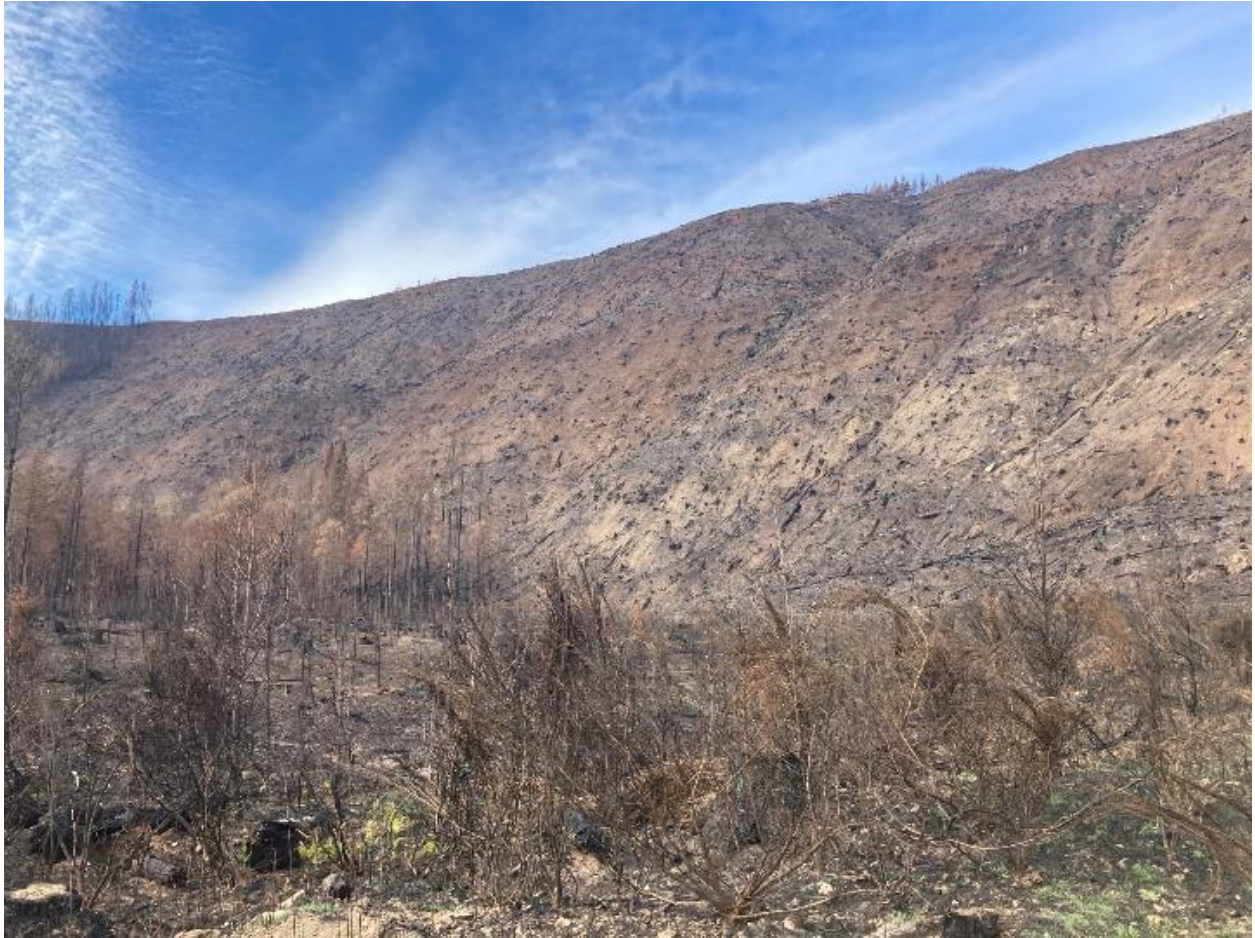
Photo 3: Very steep clear-cut areas along Rock Creek Road which could lead to sedimentation loss, rilling, possible debris flow formation.
