Riverside Fire

Erosion Threat Assessment/Reduction Team (ETART)
Extended Report

December 2020

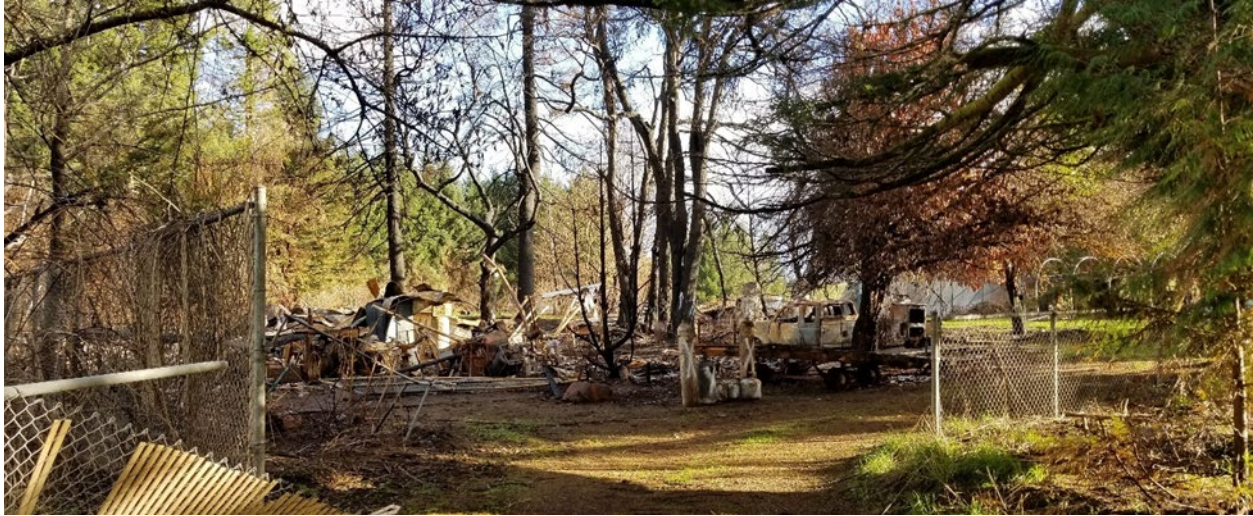
Figure 2. A rural residential home near the community of Dodge is a complete loss following the Riverside Fire. (Photo: Samuel Leininger, Clackamas SWCD)

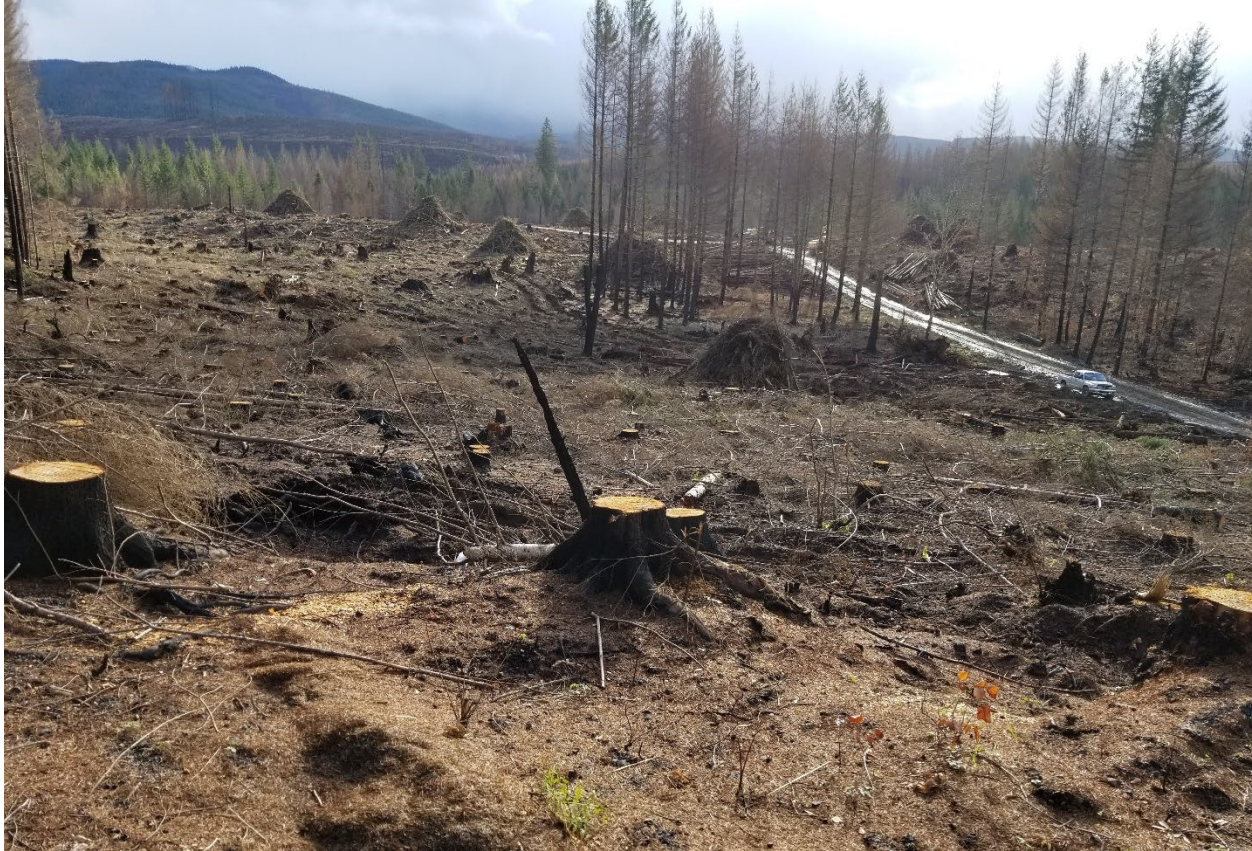
Figure 5. Salvage logging activities already underway on industrial timberlands affected by the Riverside fire. (Photo: Samuel Leininger, Clackamas SWCD)

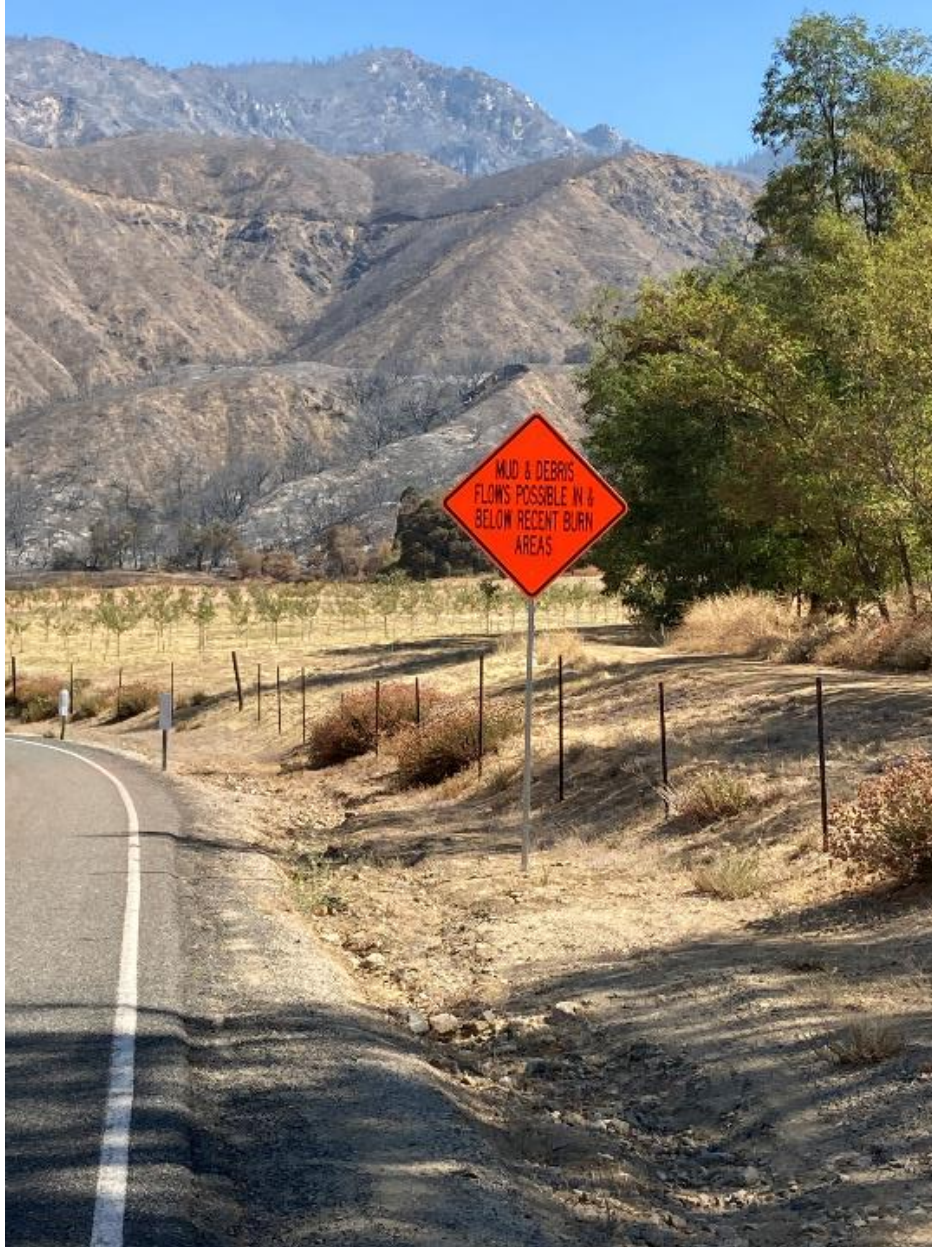
Photo 1: Example of a debris flow hazard sign that can be placed along roads impacted by the fire. Signs must have large enough letters to be read at driving speed.
