Beachie Creek Fire

Erosion Threat Assessment/Reduction Team (ETART)
Extended Report

December 2020

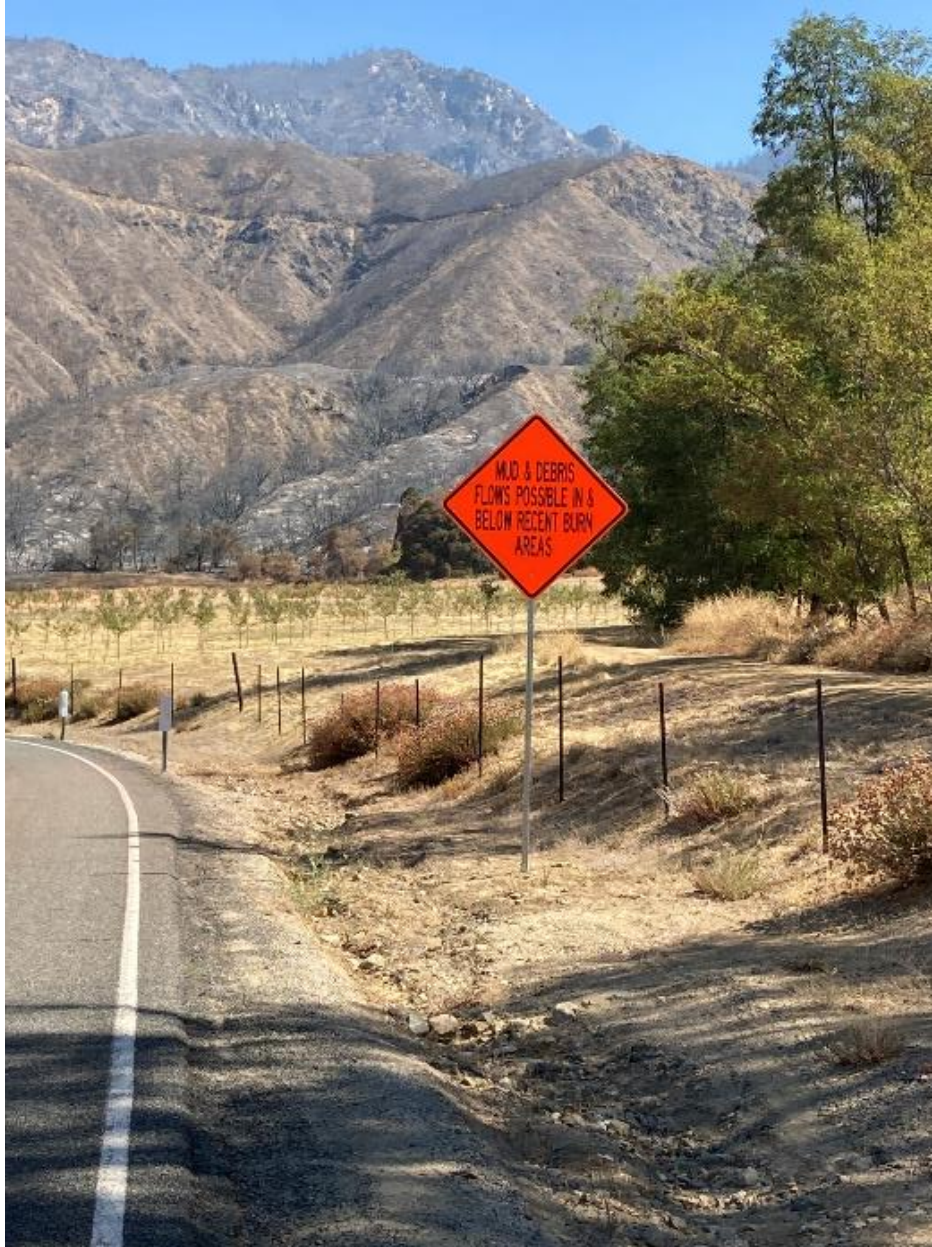
Photo 6: Example of a debris flow hazard sign that can be placed along roads impacted by the fire. Signs must have large enough letters to be read at driving speed.
