Holiday Farm Fire

Erosion Threat Assessment/Reduction Team (ETART)
Extended Report

December 2020

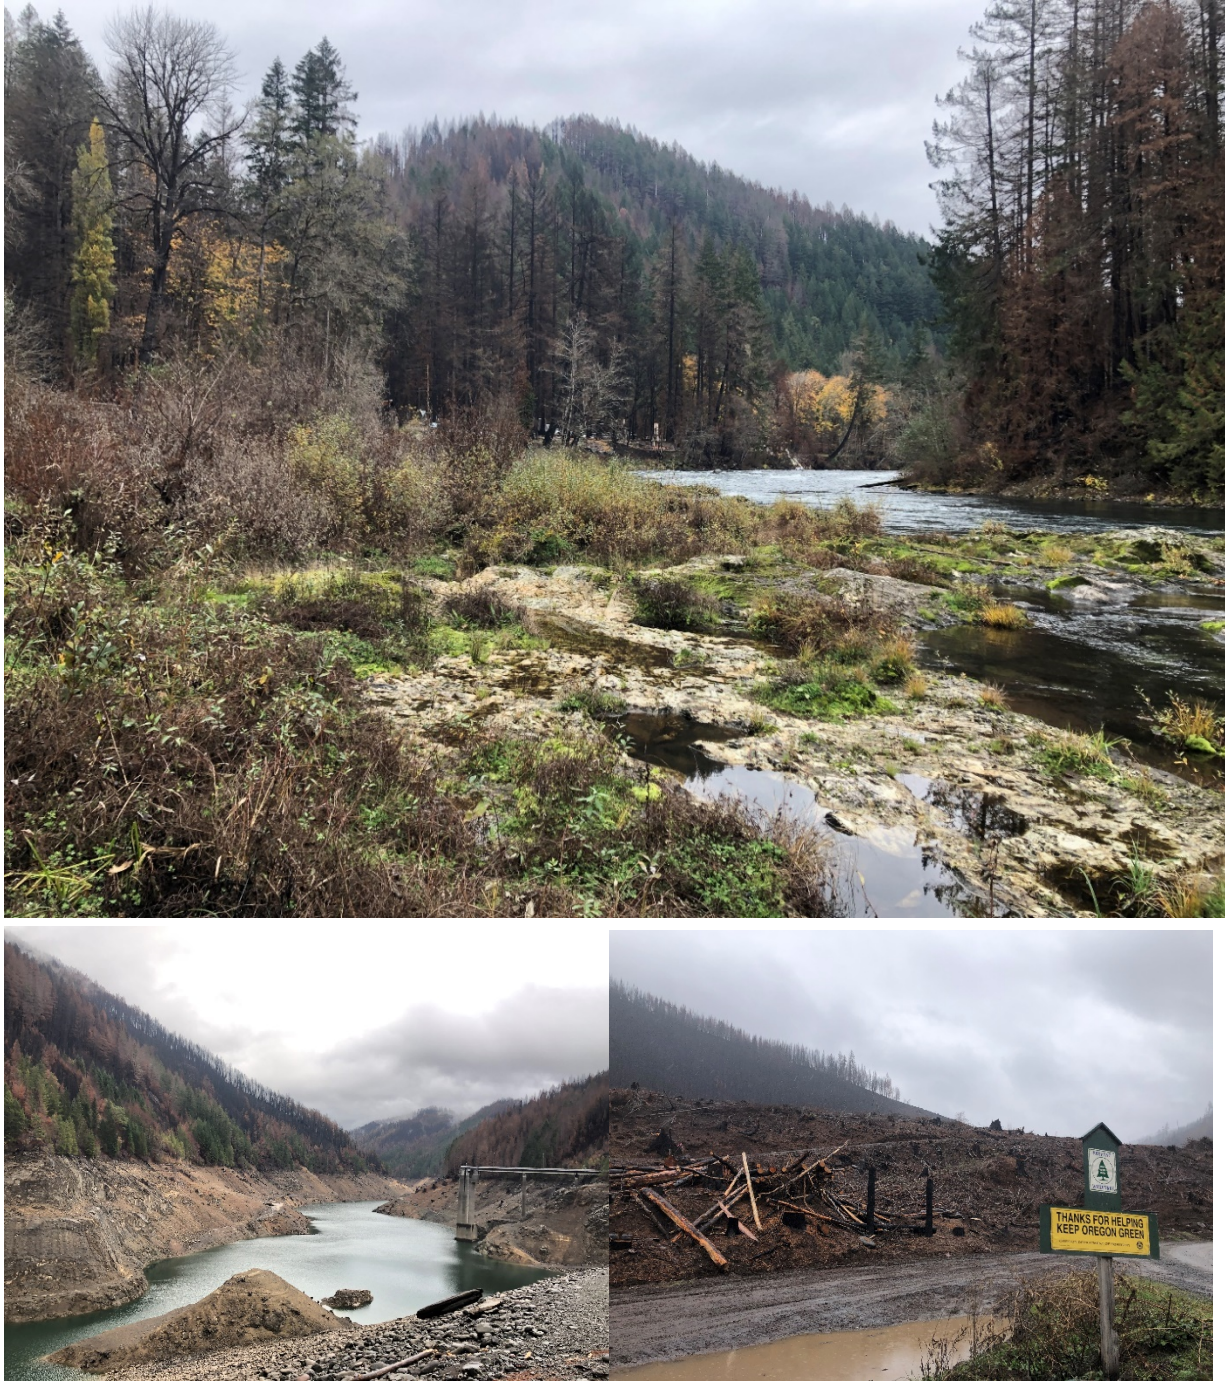
Post-fire: Historic low fuel moisture, low humidity and high winds contributed to rapid spread from the Holiday Farm Fire's ignition point near Rainbow, Oregon westward through the settlements of Blue River, Nimrod and Vida towards Leaburg. Fueled by 50mph winds, flames were quickly fanned across the landscape on either side of the mainstem of the McKenzie River, engulfing numerous residential settlements along the river in the process, as well as riparian restoration sites. All three of the McKenzie River Trust restoration sites within the fire were burned severely, as well as numerous Pure Water Partnership riparian projects. In all, over 173,175 acres burned through a mix of federally and privately managed forests, small private ownerships, county parks and community settlements.

Figure 5 Clockwise from top: McKenzie River (South Fork) near Vida with vernal pools (top center), Extensive vegetation mortality in timberlands (bottom right) near Quartz Creek, Blue River Reservoir with mosaic burn severity (bottom left)

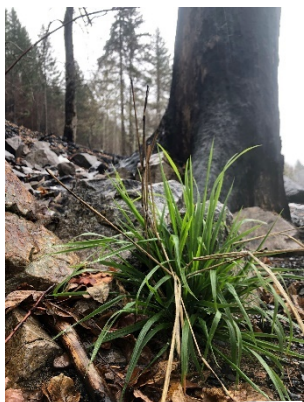
False brome (*Brachypodium sylvaticum*): Most concerning of these priority weeds are scattered small patches of false brome lining forest roads (such as those along the McKenzie River accessible from the Quartz Creek Bridge, as well as Blue River Reservoir near the HJA Andrews Research Forest – a threatened Critical Resource Value). False brome infestations build up flash fuels of dead leaf

Figure 6 False Brome in Vida

thatch than can drive & perpetuate high severity fire regimes (Pausas & Keeley 2009). While overall there did not appear to be high quantity of false brome coverage, it is very well poised to spread rapidly into adjacent burned areas. Previous studies have found false brome to increase over 1200% in weed cover density following fire, especially under conditions similar to those of the Holiday Fire where quickly moving fire greatly reduces competition from other plants (Poulos & Roy 2015). This is especially alarming given that current limited distribution of false brome is well-poised to explode across the burn areas if left unmanaged. False brome cover seems to be even more problematic in riparian corridors. In addition to preventing seedling establishment, false brome tolerates a wide range of conditions and can flourish in open and closed-canopy habitats to the point of "near complete exclusion of other herbaceous vegetation (Kaye 2011)." This trait allows false brome to invade recently

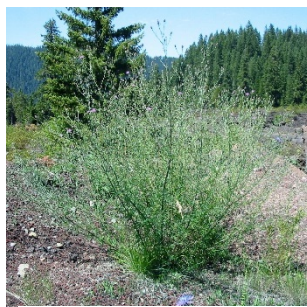
Figure 7 Spotted knapweed, pre-fire McKenzie River Valley Courtesy of Glenn Miller (ODA)

Spotted knapweed (*Centaurea stoebe*): Local ODA Noxious Weed Program Specialist Glenn Miller (pers. comm 2020) reports extensive knapweed populations along the high voltage electrical corridor from Cougar Reservoir to at least Quartz Creek. Much of this area is heavily disturbed due to pre-fire conditions and fire suppression activities, and cuts through timbered areas with very heavy vegetation mortality and soil burn severity. Knapweed seed is especially long-lived in the soil and is tolerant of fire. Dried knapweed seed can also easily be transported on equipment and thrives in disturbed habitats. Dispersal of knapweed from utility corridors, roadways and suppression lines is expected and should be anticipated in post-fire recovery planning.

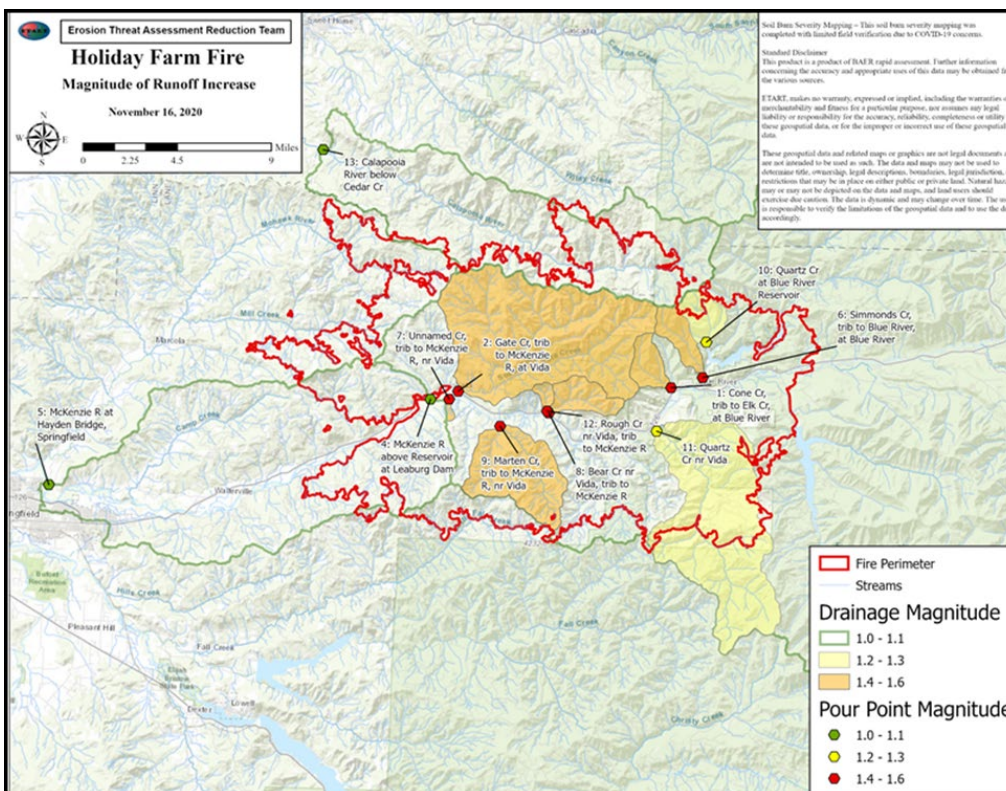
Regional regression equations were used to estimate pre- and post-fire peak flows for a number of watersheds (see appendix G, Section II for further details). The relative increase in 5-year peak flows is expected to be largest in watersheds such as Simmonds Creek, Cone Creek, and Rough Creek, where 85 to 100% of the watershed was moderately to severely burned (tables 3 and 4, figures 4 and 5). Higher peak flows on these watersheds could lead to damage of road crossing that are unable to pass the additional water and debris. Also, homes along the watersheds such as Gate Creek and Cone Creek maybe at increased risk of flooding.

Figure 5. Map of modeled magnitude increase of post-fire, 5-year peak flow for poursheds.

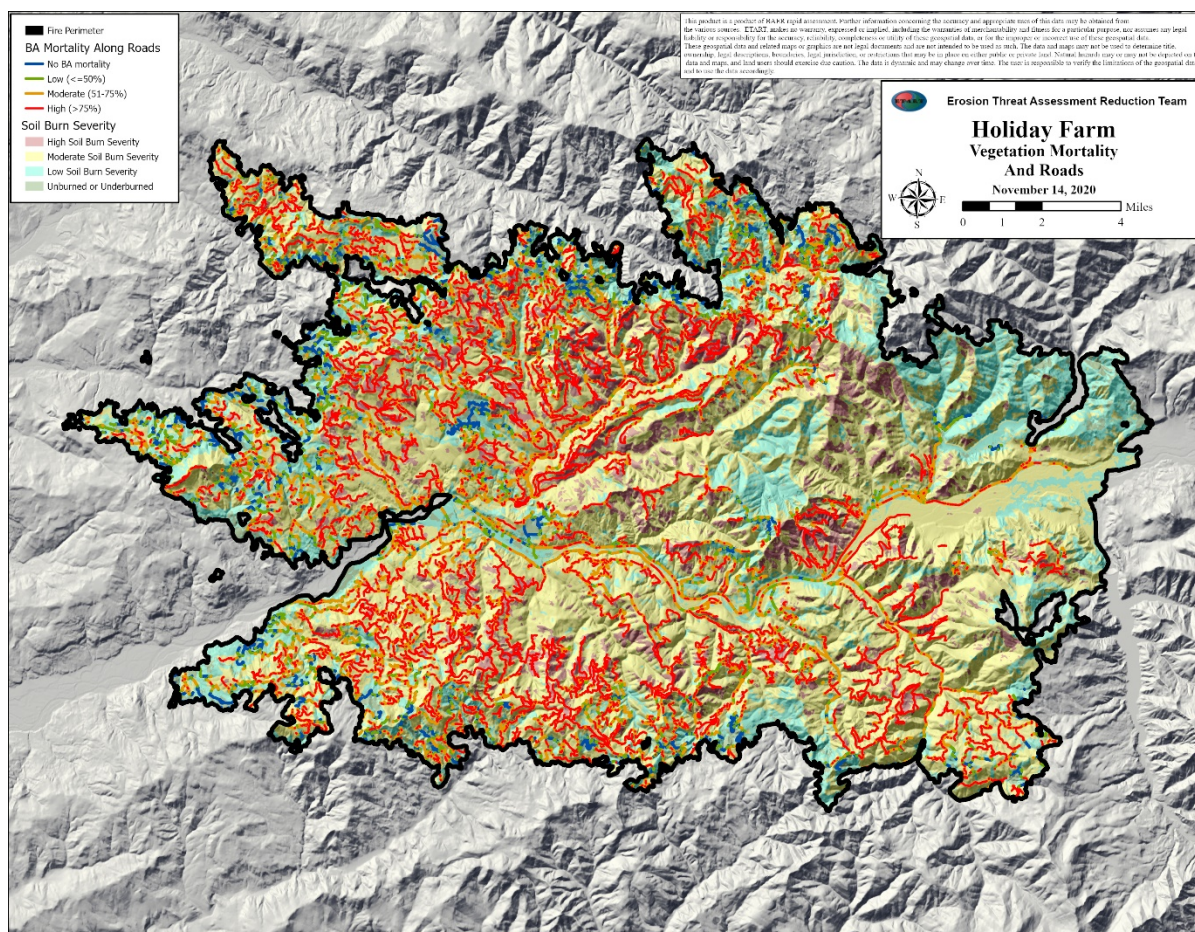
There are nearly 160 miles of roads with moderate to high levels of basal area mortality on local, state and private land (including unspecified private), with another nearly 40 miles with low basal area mortality (less than 50%; Fig. 1). Cost to mitigate danger trees along these roads will vary with the mortality that occurred due to fire, post-fire mortality that will occur within the next 3 to 5 years, as well as the size of the trees which determines the failure zone. Additional details on determining if a tree is a danger or will become a danger are discussed below in “Damage indicators likely to contribute to failure of fire-injured trees.”

Figure 1. Roads mapped by percent basal area mortality within the Holiday Farm Fire perimeter.

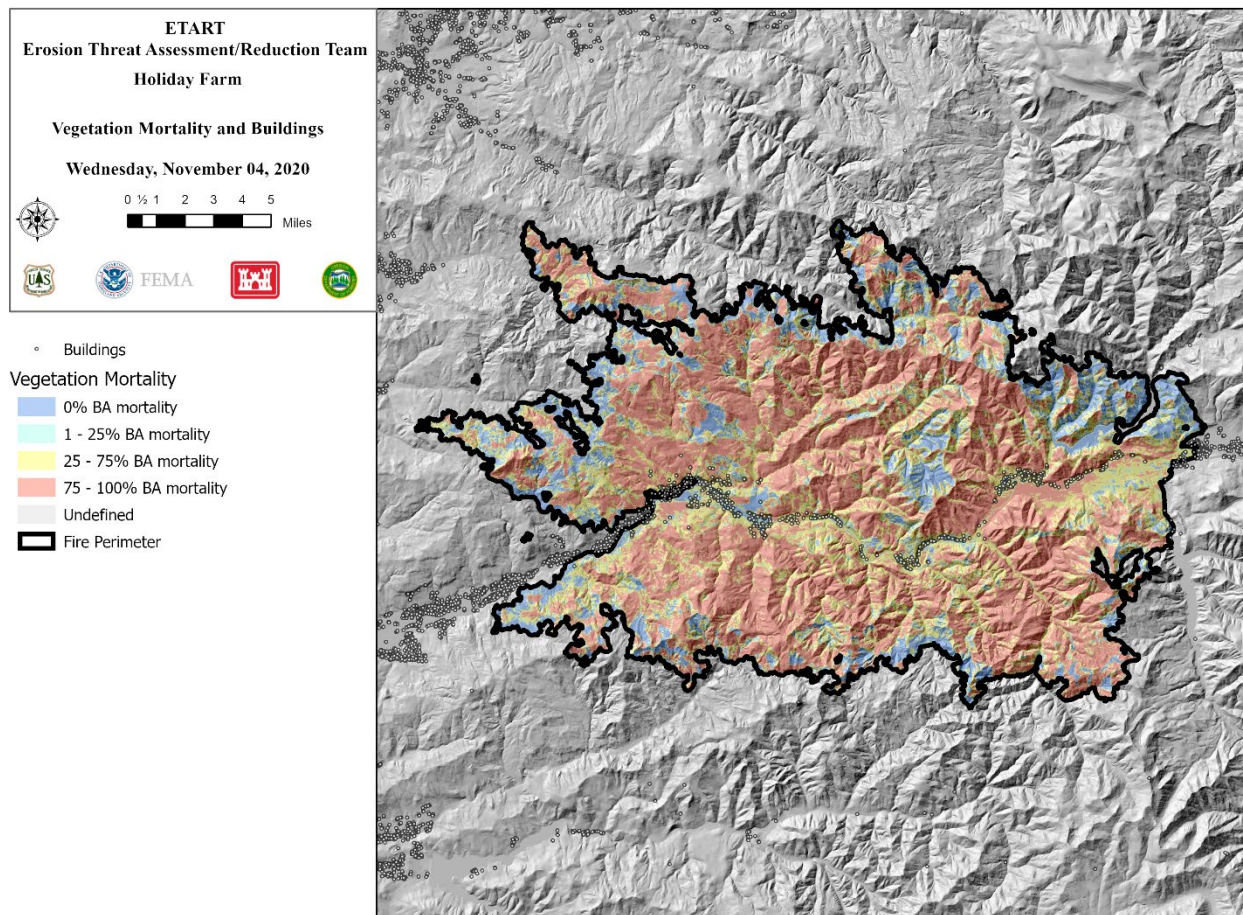
Figure 2. Location of structures within the Holiday Farm Fire perimeter and their locations relative to vegetation mortality.

There are 478 structures located in areas that suffered 50% or greater basal area mortality (Fig. 2). Another 404 structures are located in areas that suffered less than 50% basal area mortality. A 100-foot buffer was drawn around these structures and the acres calculated by basal area burn severity class to provide some guidance on the level of hazard trees that need to be mitigated. There are over 800 acres of hazard trees within the 100' buffer surrounding all structures. The radius of 100 feet was used as a surrogate for tree height, which determines the failure zone. The actual failure zone around structures may be less with shorter trees and greater with taller trees. Additional details on determining if a tree is a hazard or will become a hazard are discussed below in “Damage indicators likely to contribute to failure of fire-injured trees”.

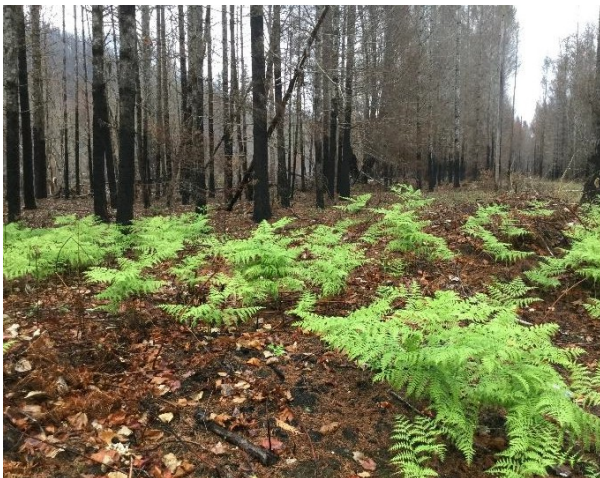
Above: Bracken fern flourishes in the post-burn landscape at Finn Rock Landing.

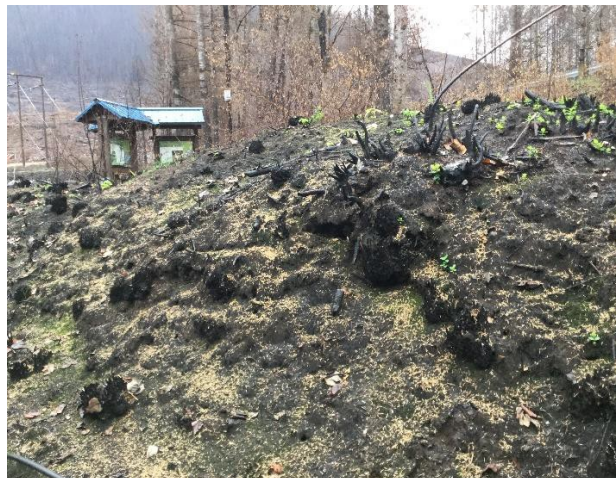
Above: High vegetation mortality has left bare ground exposed, which was recently seeded with native grasses.

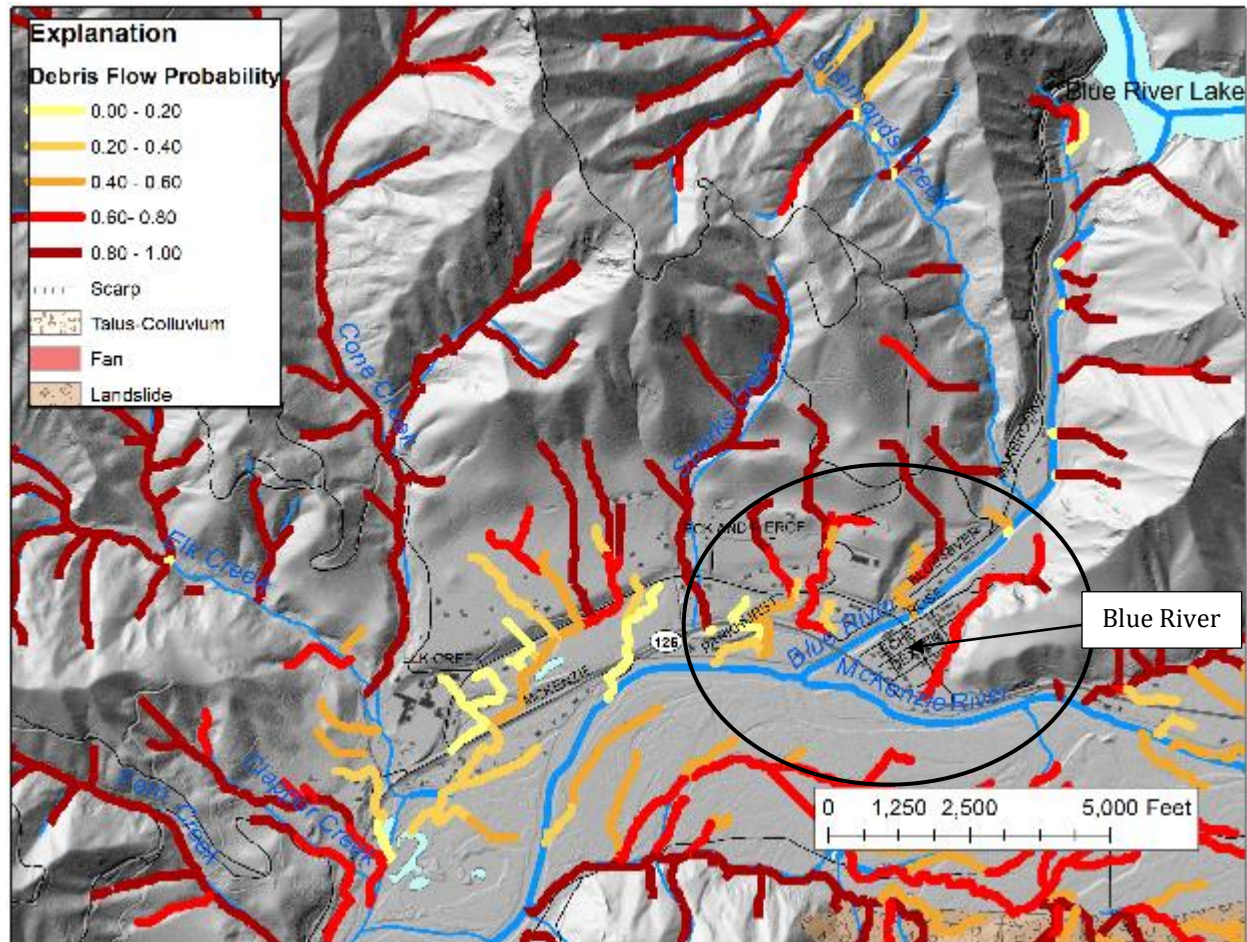
Communities of Blue River – Portions of Blue River are located below channels identified by the USGS as moderate and high potential for debris flows (Appendix D, Figure 2 and Photo 1). Furthermore, portions of these communities are built on debris flow fan deposits, which is the runout/deposition zone for any potential debris flow from channels above. Lane County has already placed debris flow warning signs on roads in community. However, further hazards evaluation is recommended for the K-12 school and structures located in or near channels with moderate to high debris flow hazards.

Figure 2: Buildings and infrastructure are at potential landslide risk in the town of Blue River. Map includes USGS debris flow hazard channels and DOGAMI SLIDO areas. Potentially high debris flow hazard emanating from drainages from the steep slopes on the east and west sides of town.

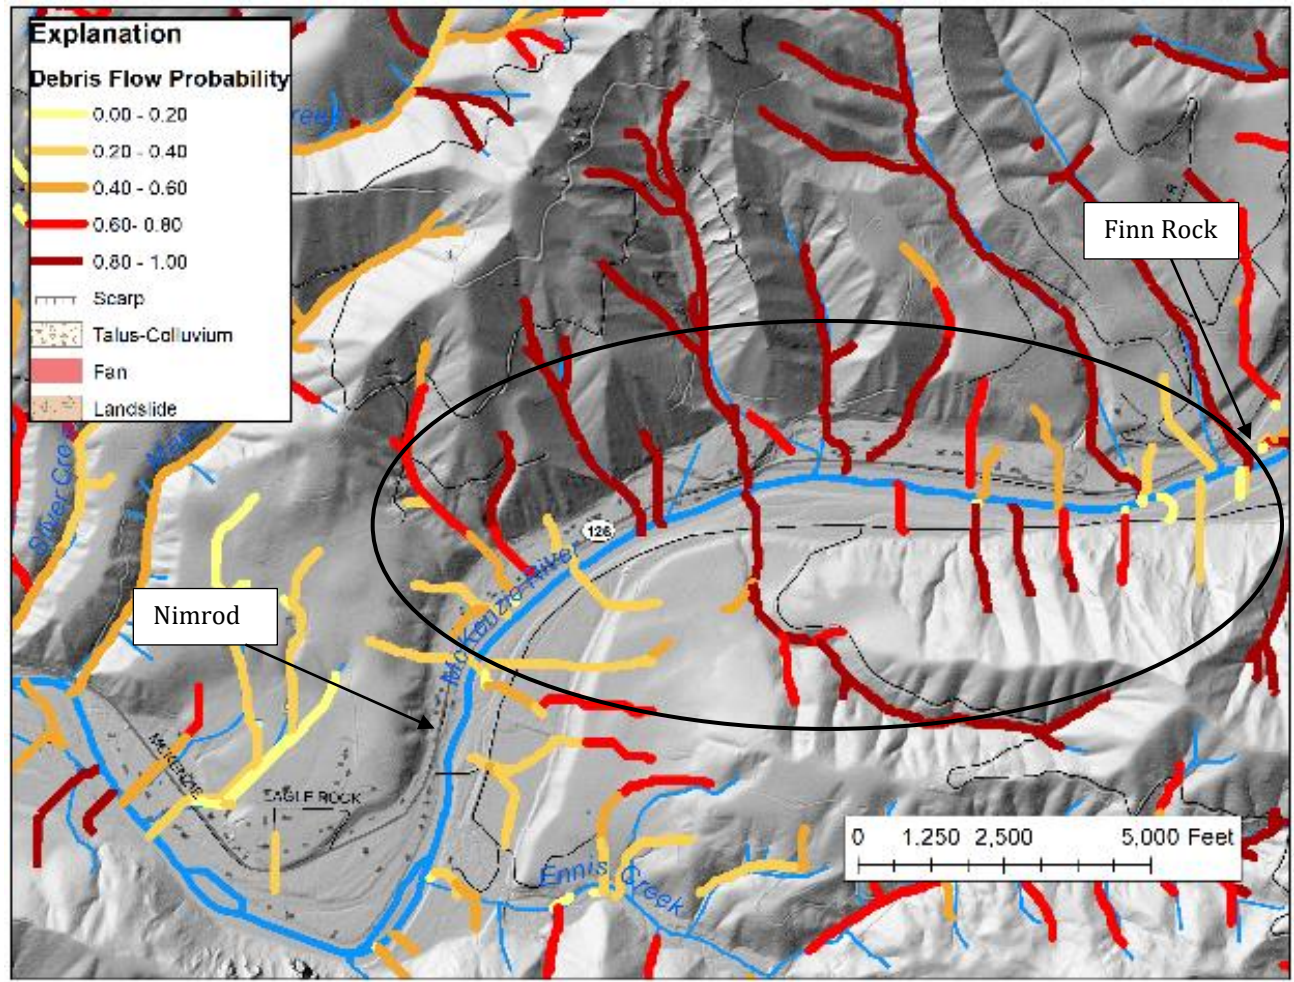
Communities of Nimrod, Vida, and along Oregon State Route 126 – Communities along OR126 including Vida and Nimrod areas are in the runout/deposition zone below channels identified by the USGS as moderate and high potential for debris flows (Appendix D, Figure 3 & 4). Recommend alerting the communities and placing warning signs along the roads.

Figure 3: Communities between Nimrod and Finn Rock along OR126 are at risk of debris flow. Potentially high to very high hazard emanating from unnamed drainage above structures located near or at the base of steep channels. Map includes USGS debris flow hazard channels and DOGAMI SLIDO landslide areas.

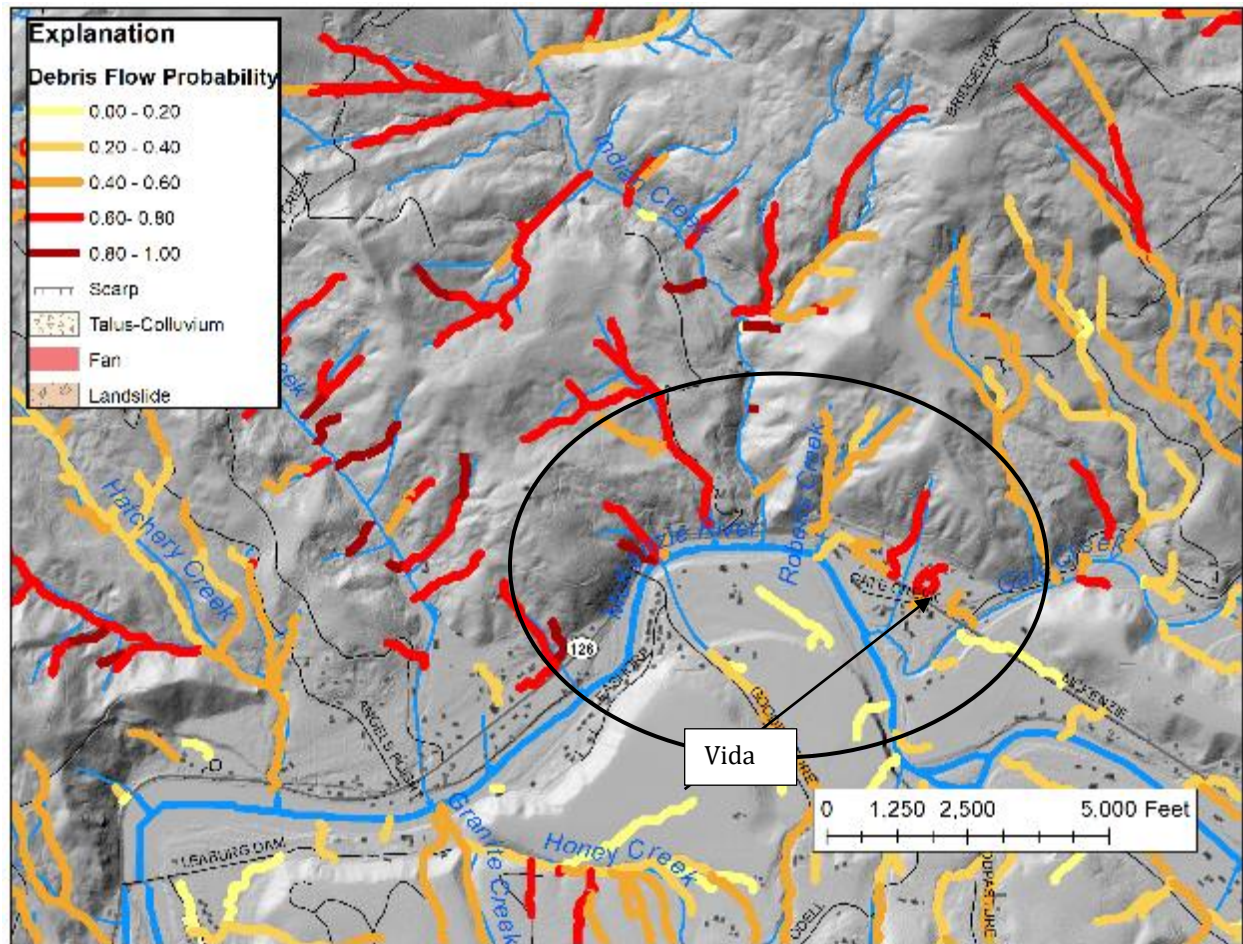
Figure 4: Communities near Vida and along OR126 are at risk of debris flow. Potentially high to very high hazard emanating from unnamed drainage above structures located near or at the base of steep channels. Map includes USGS debris flow hazard channels and DOGAMI SLIDO landslide areas.

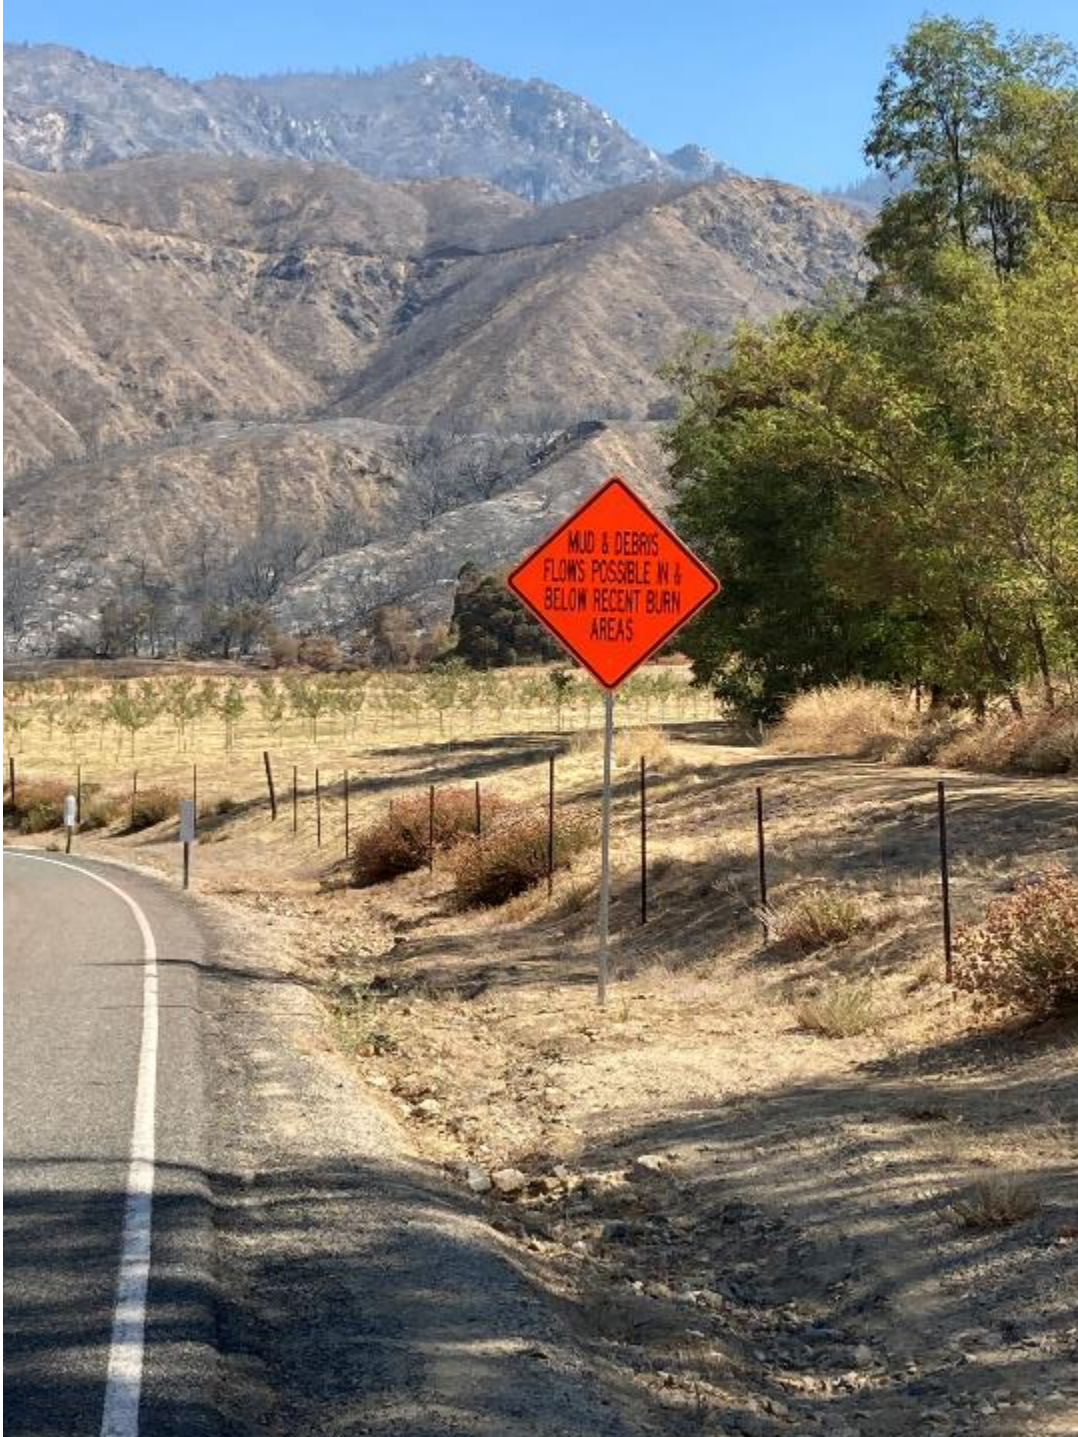
Photo 5: Example of a debris flow hazard sign that can be placed along roads impacted by the fire. Signs must have large enough letters to be read at driving speed.

At many sites, we recommend signs are placed in locations to help awareness and remind everyone of the potential risk. These signs should include a clear message and a link to additional information (Appendix D, Photo 5).
