# Holiday Farm Fire

Erosion Threat Assessment/Reduction Team (ETART)  
Summary Report

December 2020

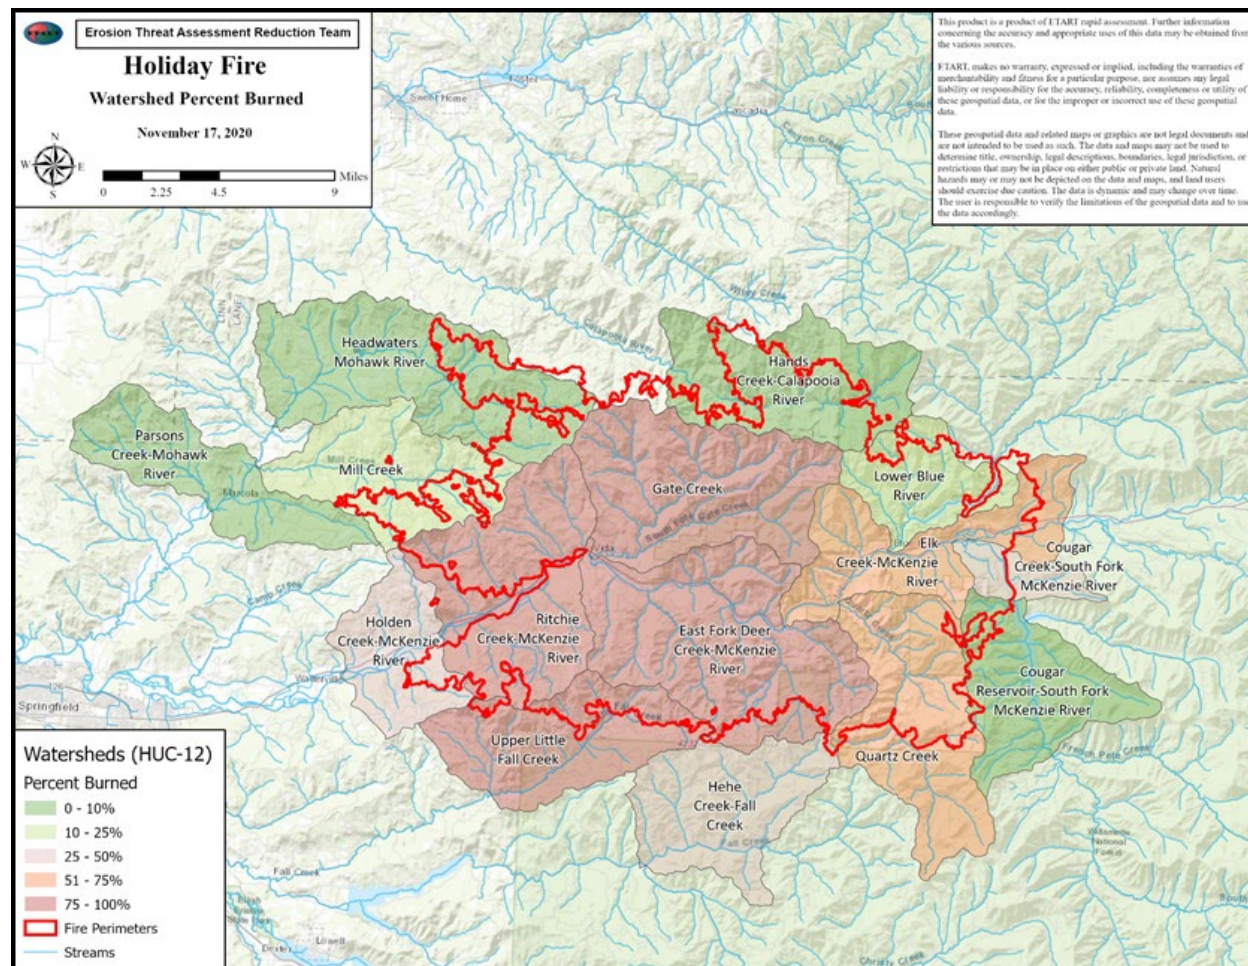
**Figure 2. Watersheds Percent Area Burned – Holiday Farm Fire**

The fire perimeter occurs in eight 5th level hydrologic units (watersheds) and nineteen 6th level hydrologic units (subwatersheds). The percent area burned for the 6th Level subwatersheds are displayed in Figure 2 and summarized in Table 3. The primary drainages within or downstream of the
